## Strata Scheme Roof Inspection Report

Perth strata scheme  
Address withheld

Elevate Roof & Building  
Solutions Pty Ltd  
Perth, Western Australia

# STRATA SCHEME ROOF INSPECTION REPORT

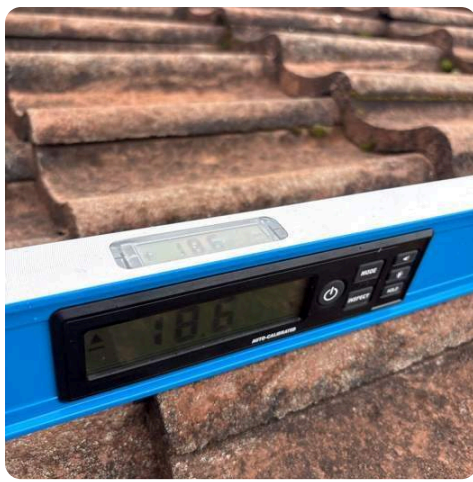
Roof pitch reading, approximately 18.6 degrees at 1x test location

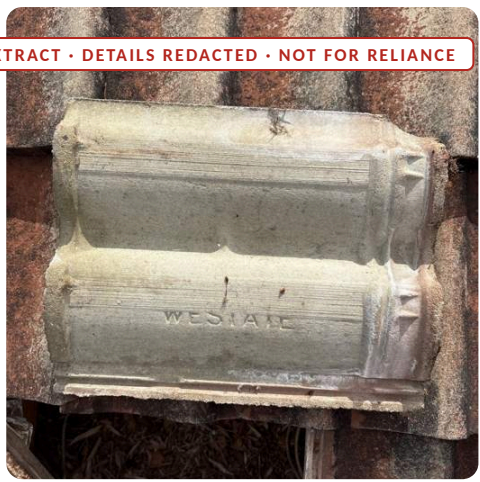
Tile underside showing moisture on the tile body, consistent with moisture retention, no sarking beneath

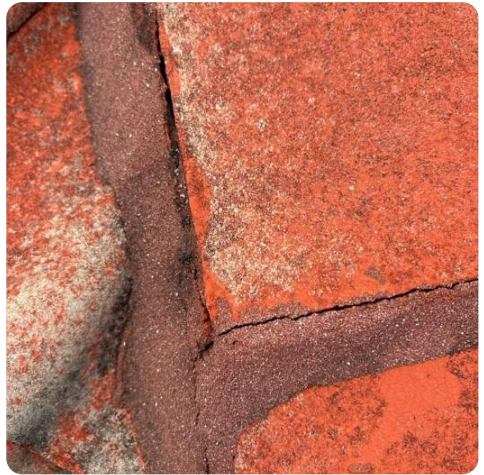
Cracked bedding at hip and ridge junction with coating breakdown

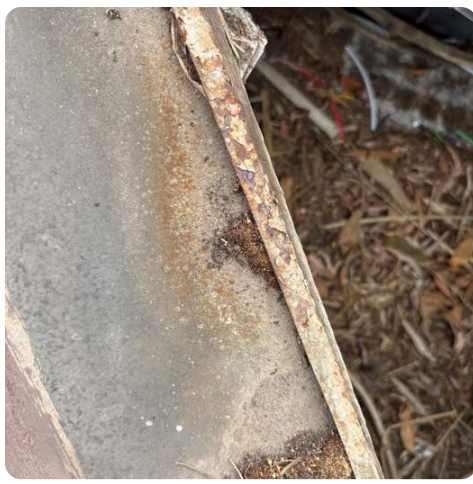
The original valley irons across the scheme are beginning to rust along their exposed surfaces and edges. The upturned edges are undersized against current installation practice and in places have been flattened against the tiles, and organic matter is trapped beneath the tile cuts along the length of most valleys. The combination reduces the valley's capacity, allows debris dams to form, and increases the likelihood of water overtopping the flattened upturn into the roof space during heavier rainfall. This condition is system wide and the valleys are recommended for replacement across the whole scheme as part of the restoration.

Valley flashing upturn undersized and corroding, organic matter beneath tiles

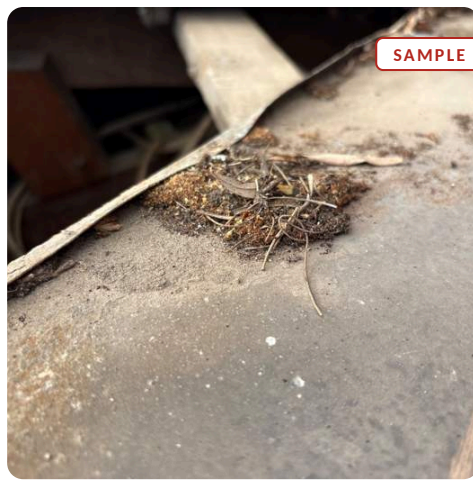
Valley upturn flattened, organic matter build up in valley

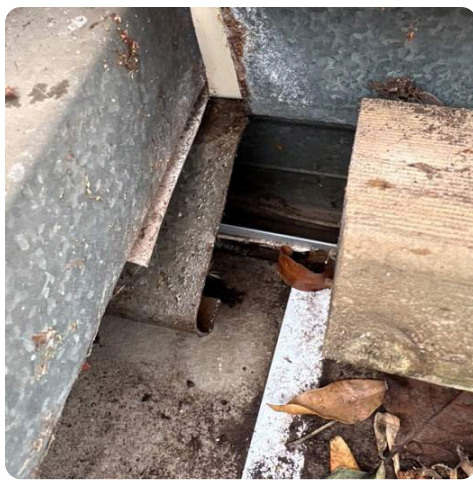
Gutter to downpipe connection, corrosion and debris, suspected leak point into the eaves

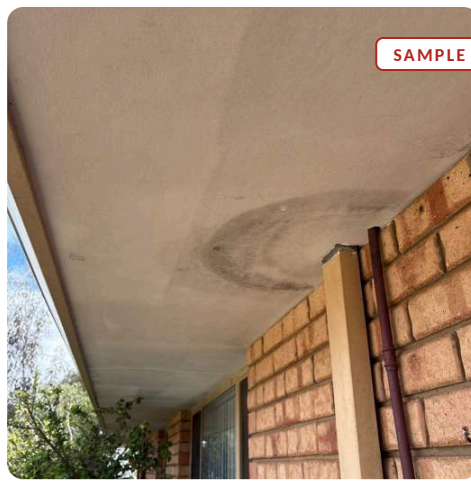
Moisture staining to eaves lining at the downpipe entry, consistent with leakage from the internal downpipe elbow

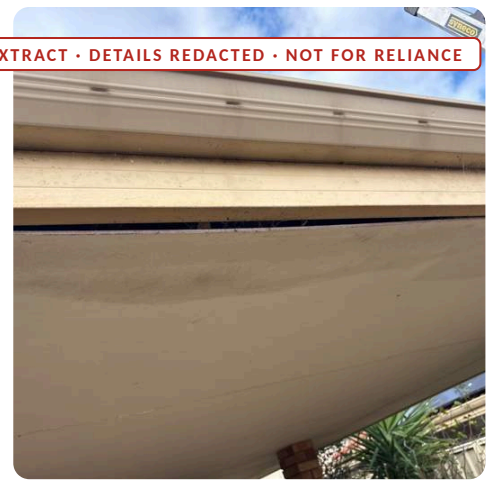
Eaves lining separated from fascia trim leaving open gap

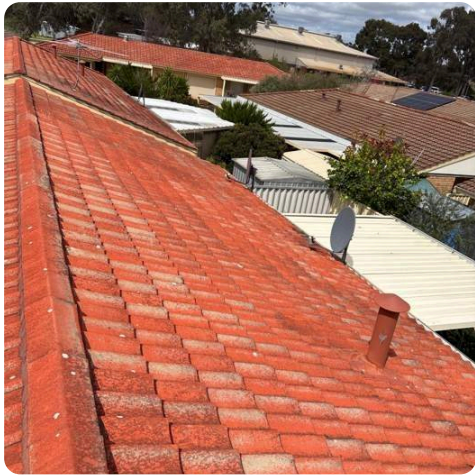
Vent pipe penetration through the tiles with painted cowl

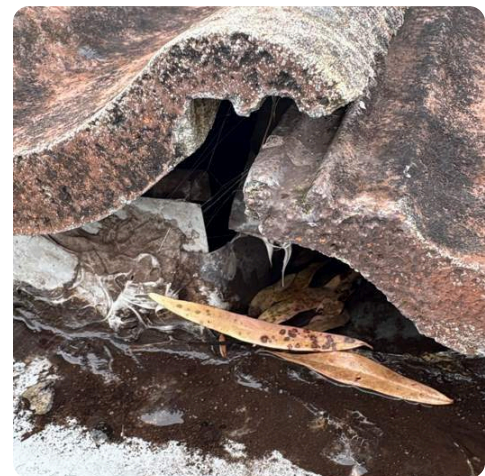
Broken eaves course tile at the gutter line, opening allows water to bypass into the eaves

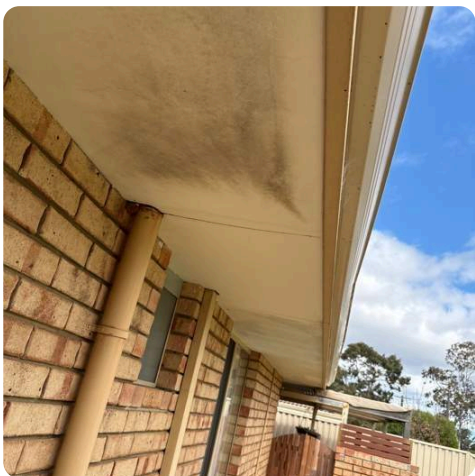
Moisture staining to eaves lining adjacent to downpipe consistent with leakage at the gutter to downpipe connection

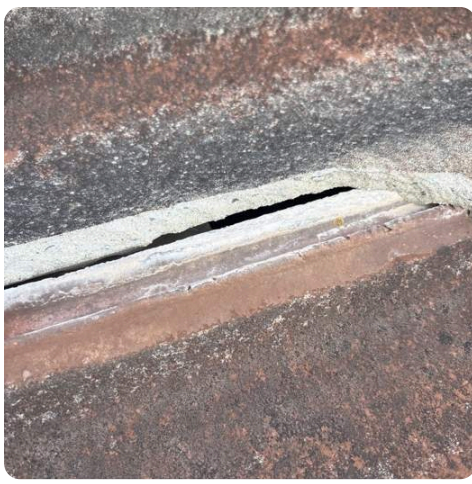
Cracked tile with lap lifted, open gap into the roof space

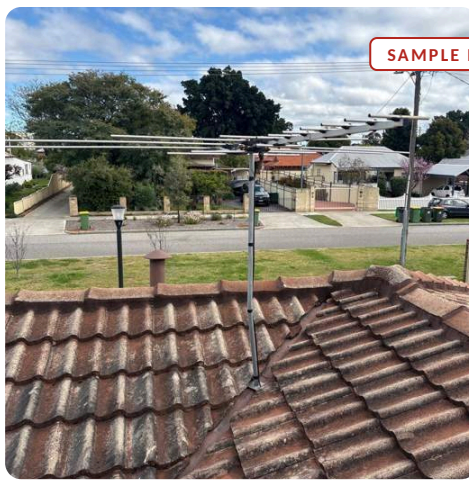
TV antenna mast mounted in the valley flashing

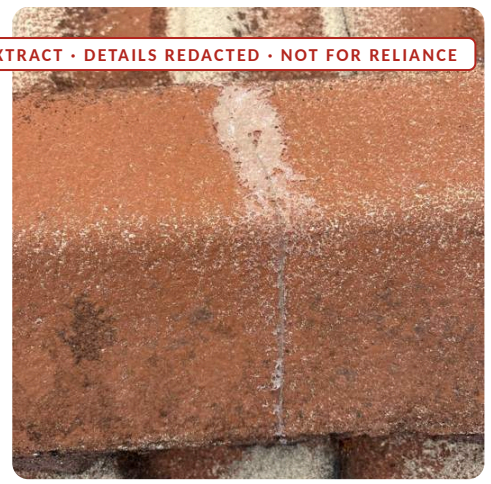
Cracked ridge cap with historic silicone repair

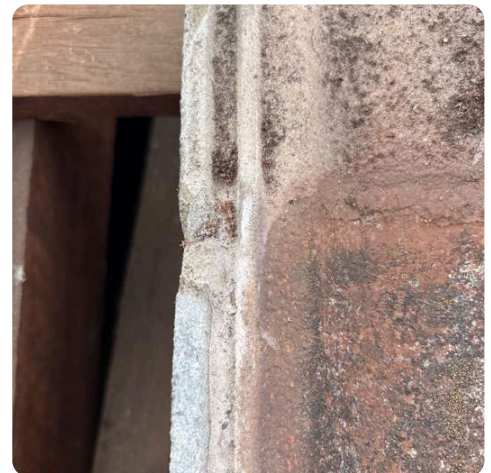
Tile course lifted and misaligned at the party wall line, tile edge sitting proud

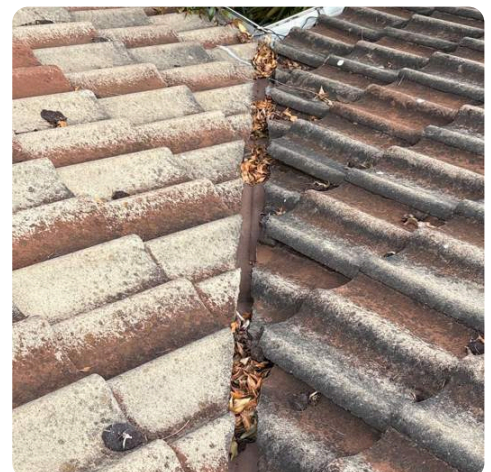
Organic matter in valley, sealed broken tile at valley head

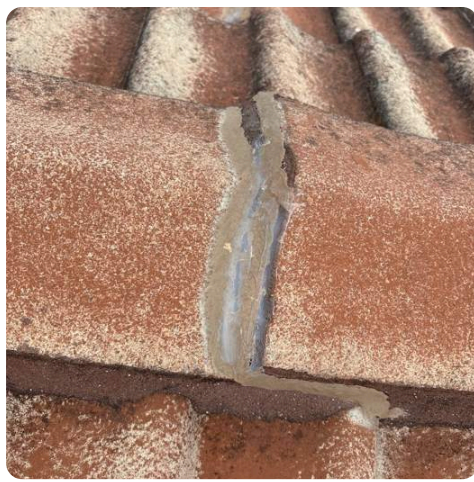
Sealant applied over cracked ridge cap joint

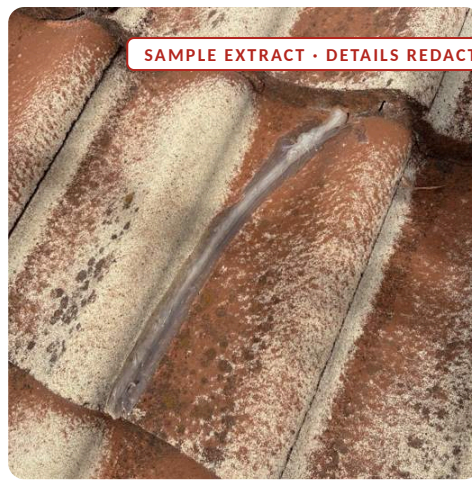
Silicone sealed cracked tile at side lap

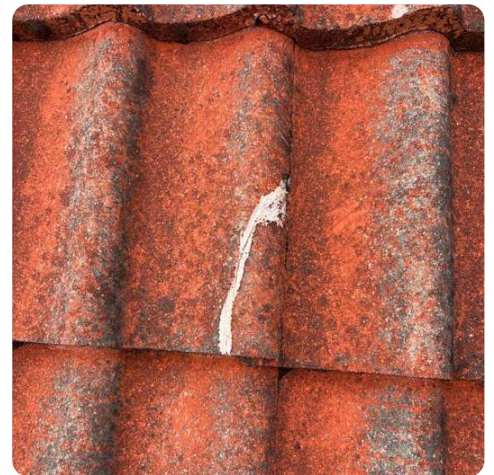
Sealed cracked tile

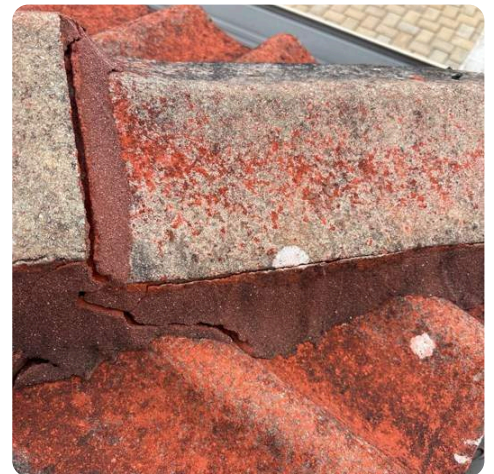
Cement bedding cracked and separated beneath hip capping

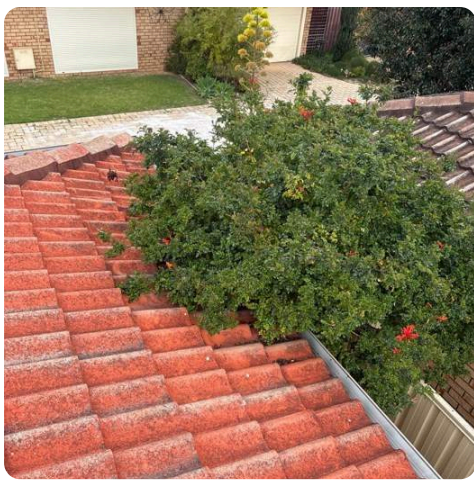
Shrub overhanging gutter at hip corner

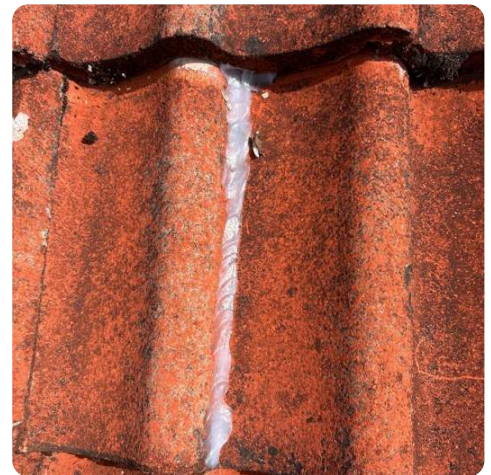
Cracked tile previously sealed with silicone, temporary repair only

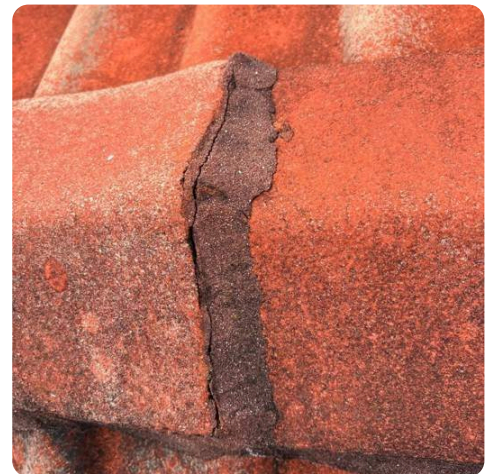
Cracked and separating cement bedding to ridge capping joint

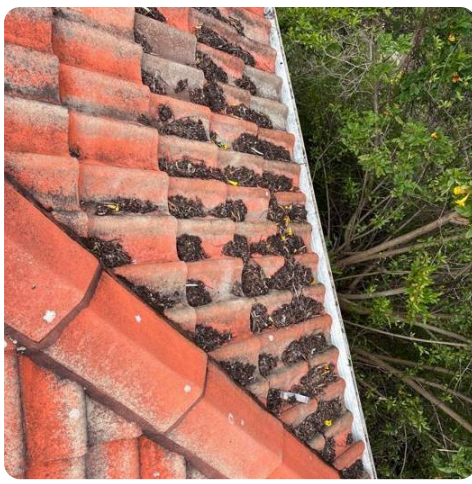
Organic matter build up to tiles at eave edge beneath overhanging vegetation

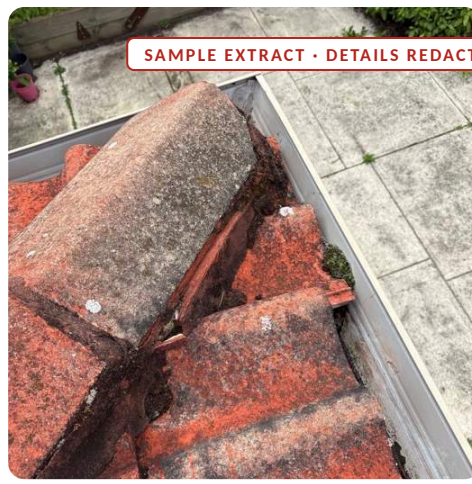
Cracked bedding and moss growth to hip capping end at gutter corner

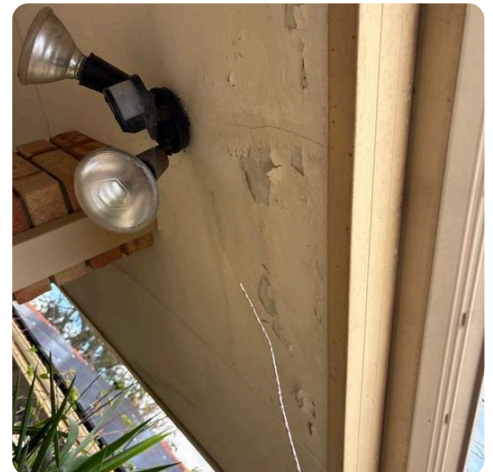
Peeling paint and cracking to eaves lining around sensor light

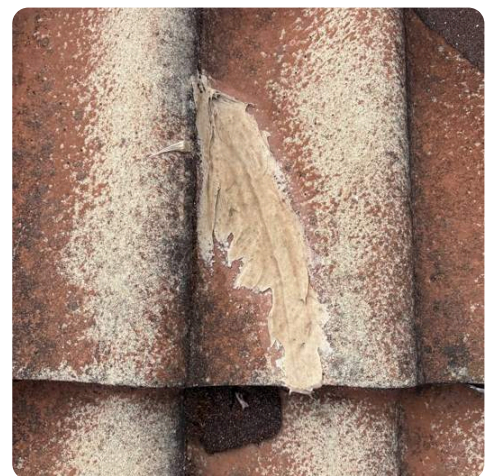
Broken tile previously patched with mortar, temporary repair only

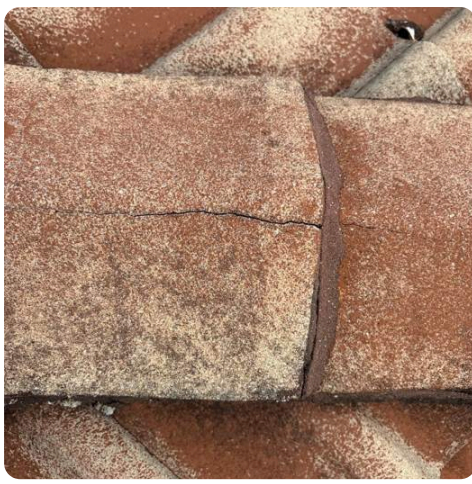
Cracked ridge capping tile

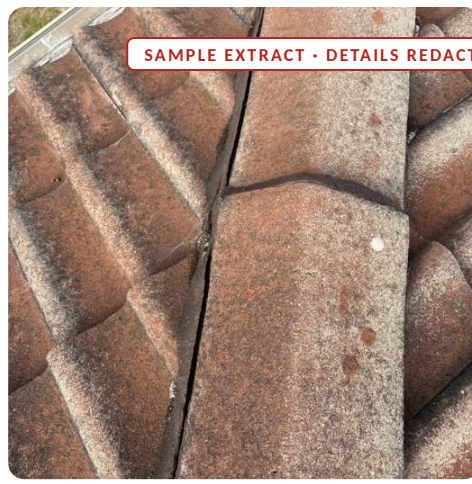
Eroded cement bedding and cracked pointing along hip capping

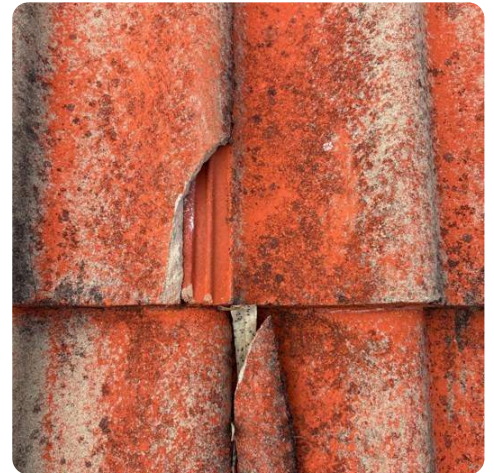
Broken tile with fragment lying on course below

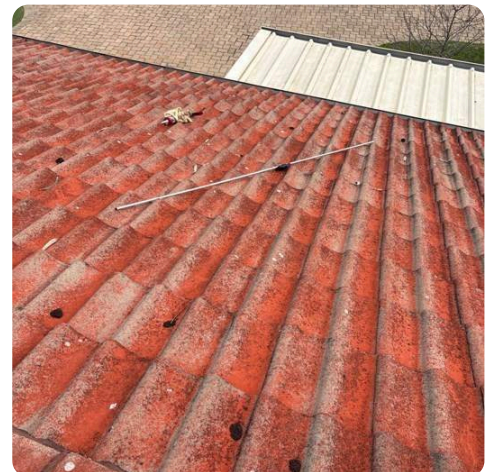
Broken antenna arm lying loose on roof surface

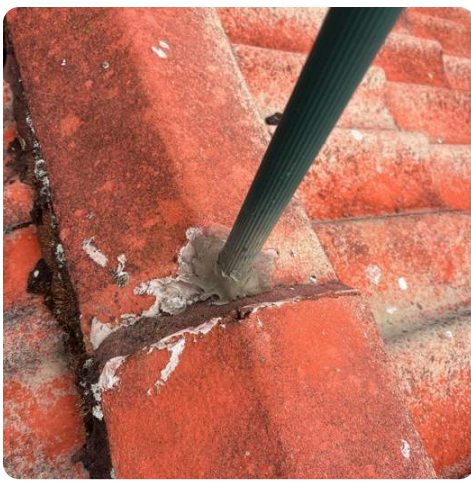
TV antenna mast chased through capping and sealed with silicone only, no Dektite

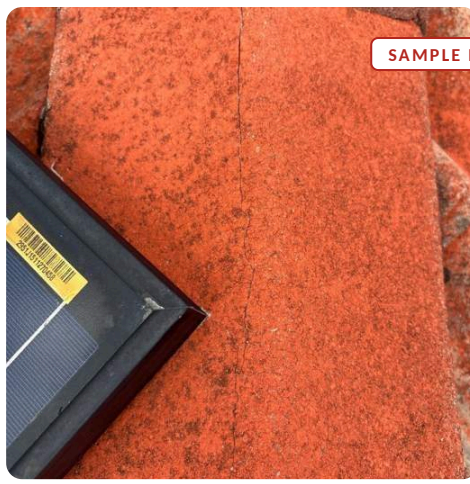
Cracked ridge capping tile adjacent to solar panel frame

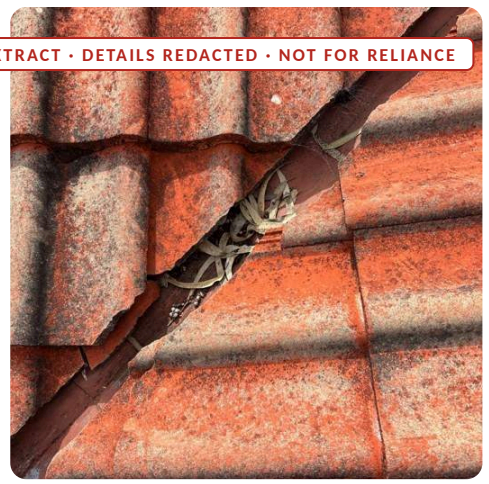
Organic matter trapped in valley beneath tile edges

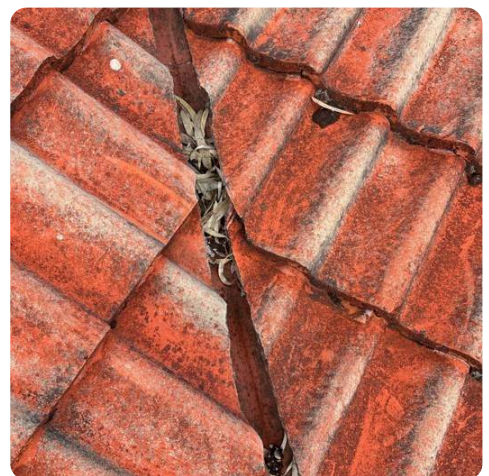
Leaf litter and organic matter trapped in valley beneath tile cuts

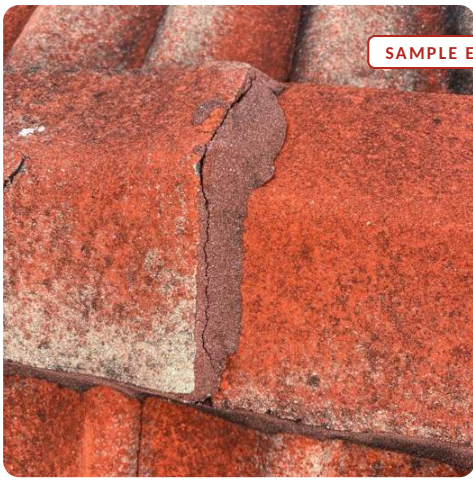
Cracked and separated cement bedding at ridge capping joint

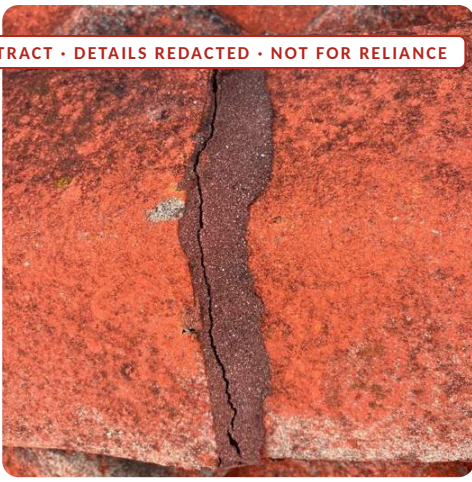
Cracked and lifting cement bedding to ridge capping joint

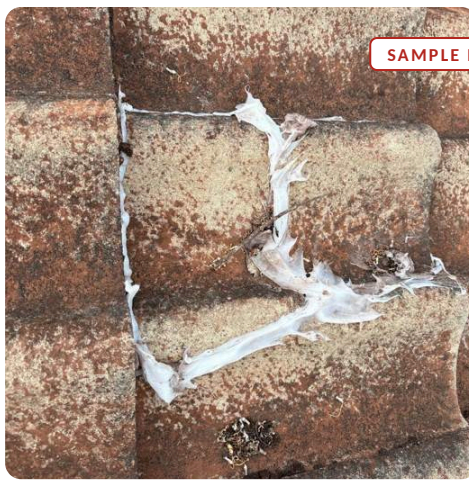
Cracked tile previously silicone sealed, sealant weathered and lifting

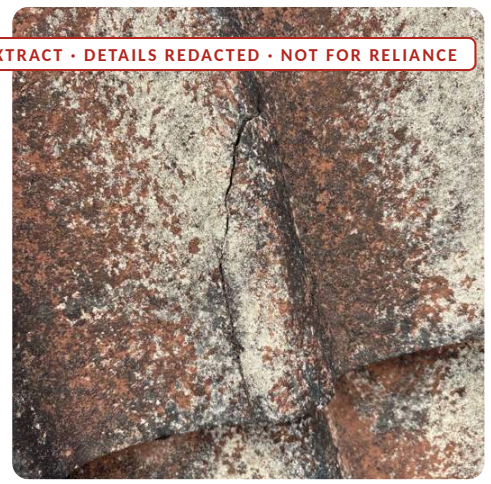
Cracked tile through crest and pan

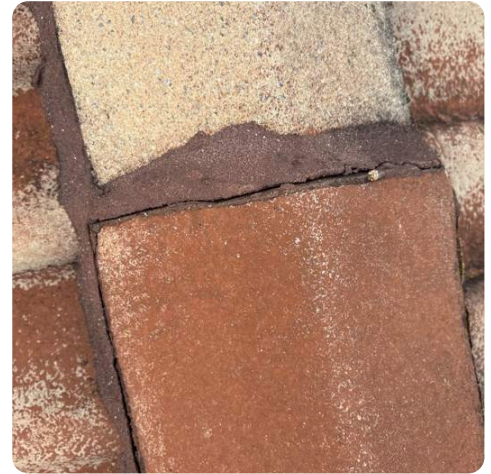
Cracked cement bedding at ridge capping joint, mismatched replacement capping evident

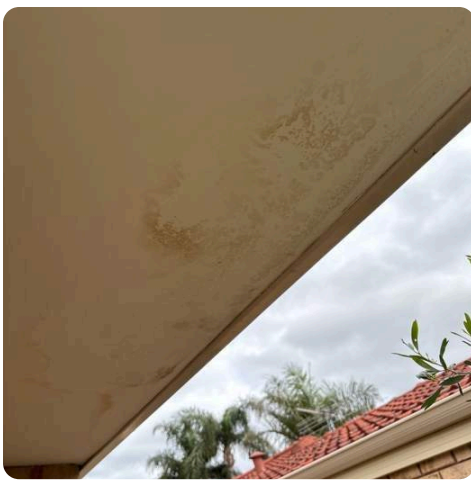
Moisture staining consistent with leakage and blistered paint to eaves lining at gutter edge

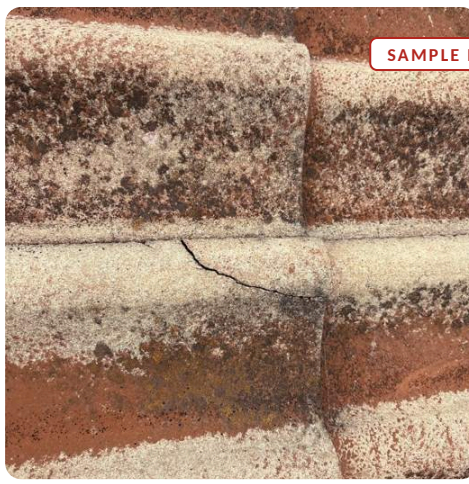
Cracked tile through pan

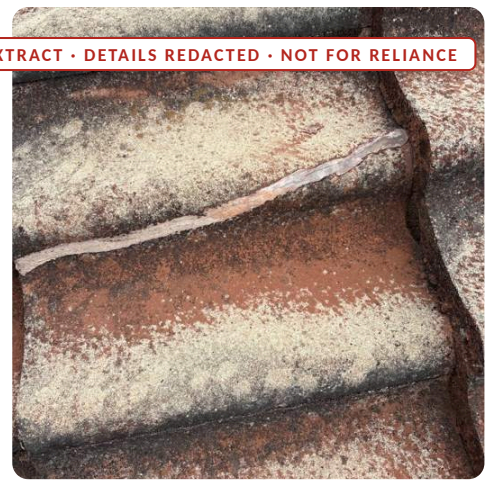
Cracked tile previously silicone sealed across pan

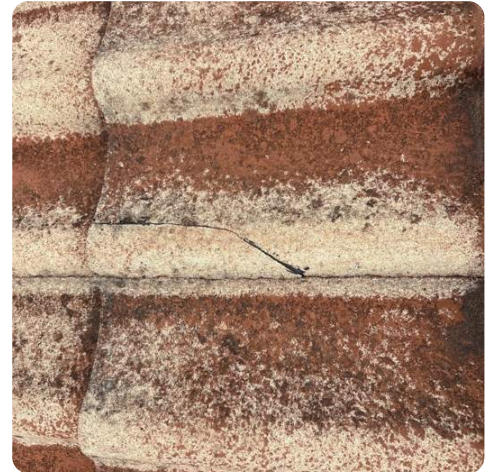
Cracked tile with failed prior sealant repair

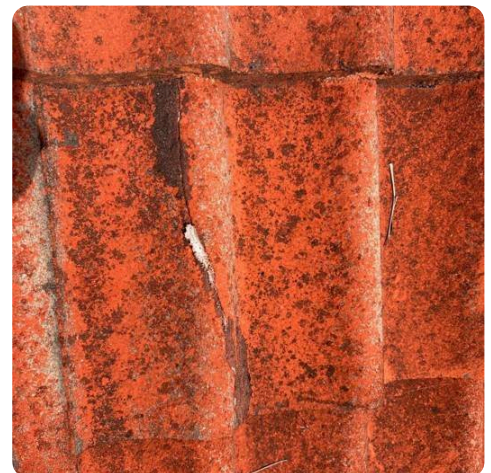
Cracked tile with a section of the tile face broken away along the crack line

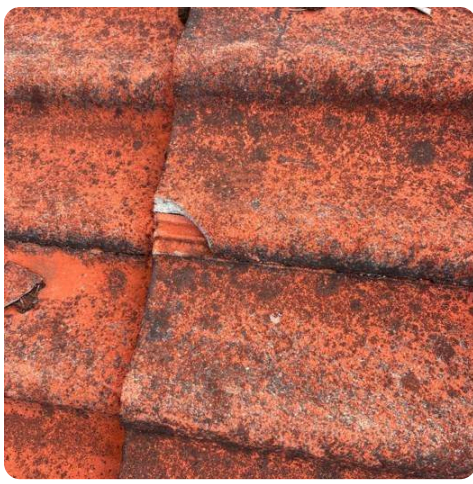
Broken tile with section missing at the side lap, fragment lying on adjacent tile

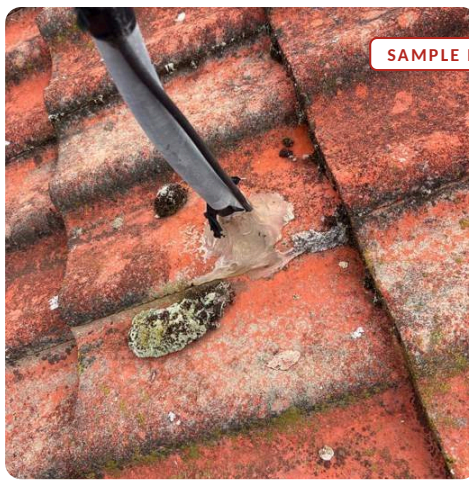
TV antenna mast chased through tile and sealed with sealant only, no Dektite

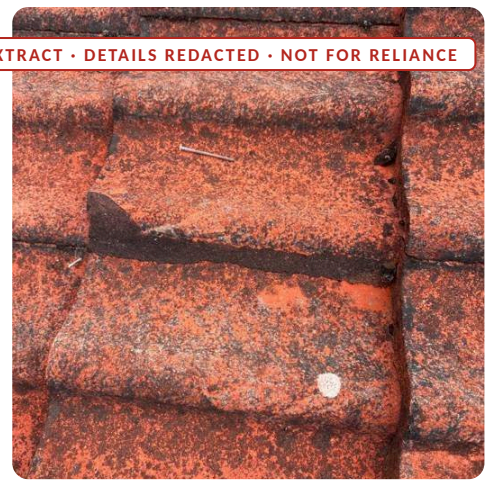
Loose roofing nail on tile surface, adjacent tile with chipped lower edge

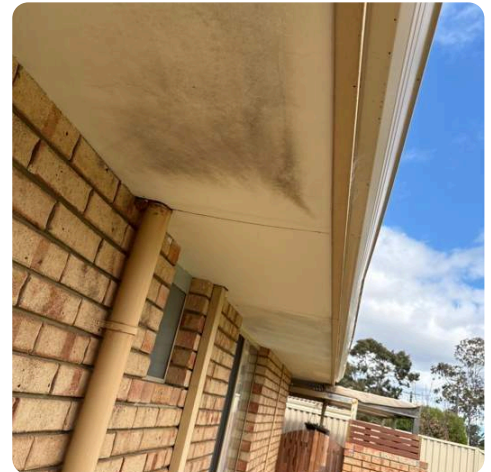
Moisture staining to eaves lining adjacent to downpipe consistent with leakage at the gutter to downpipe connection

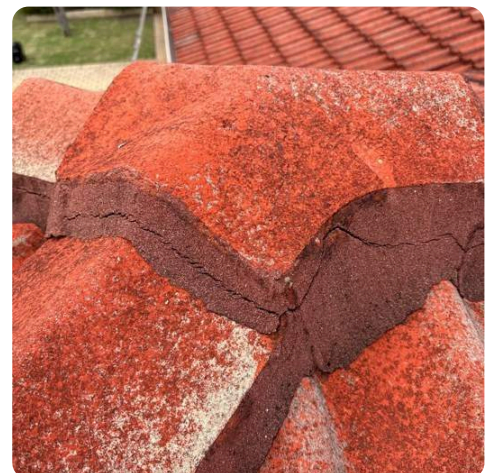
Cracked and separating cement bedding to ridge capping

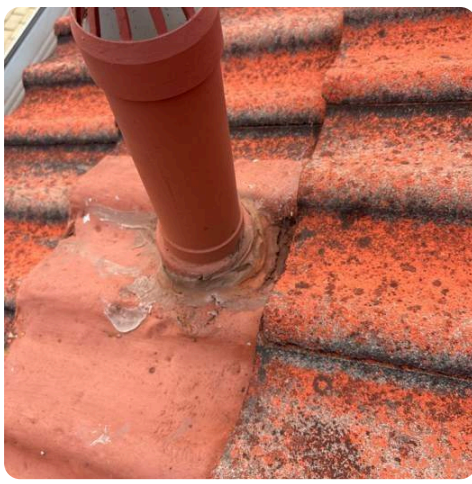
Cracked and deteriorated silicone seal to flue collar and flashing

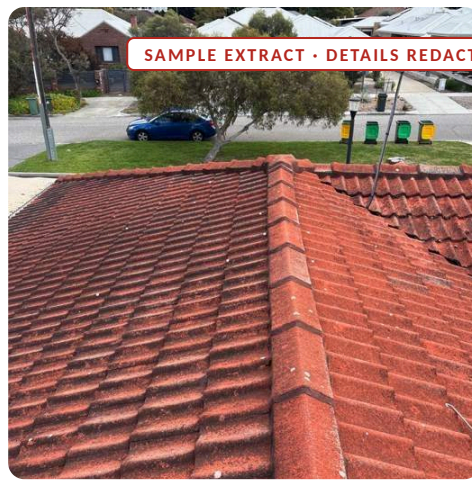
Hip and ridge junction, tiles misaligned adjacent to the right hand hip

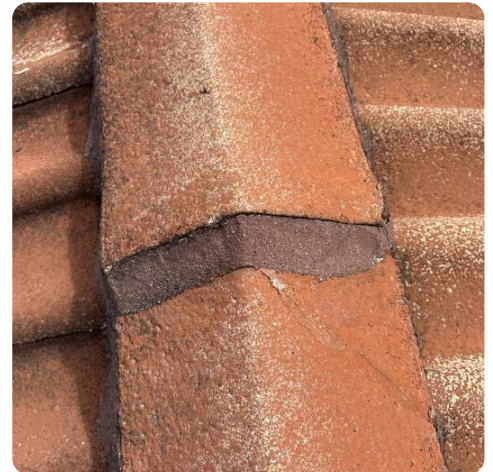
Hairline crack to ridge capping running from the bedding joint

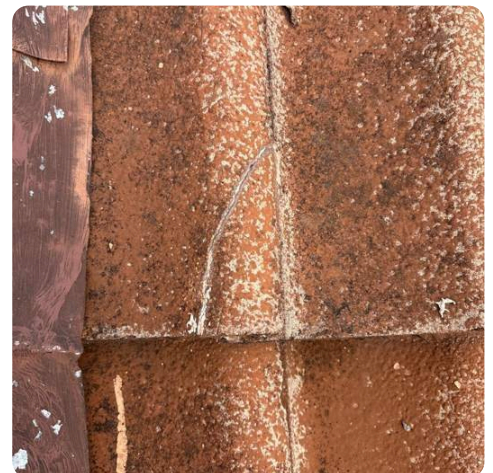
Silicone sealed crack to tile adjacent to the valley flashing

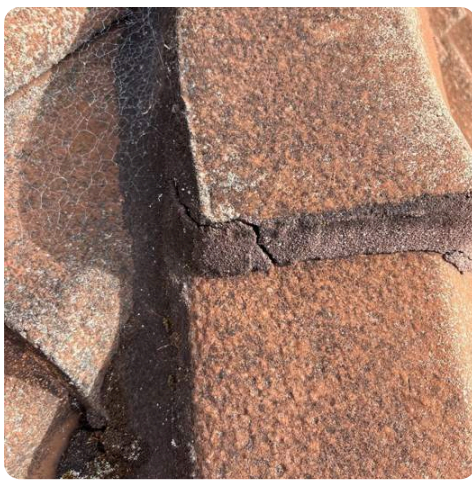
Cracked and separating cement bedding to hip capping

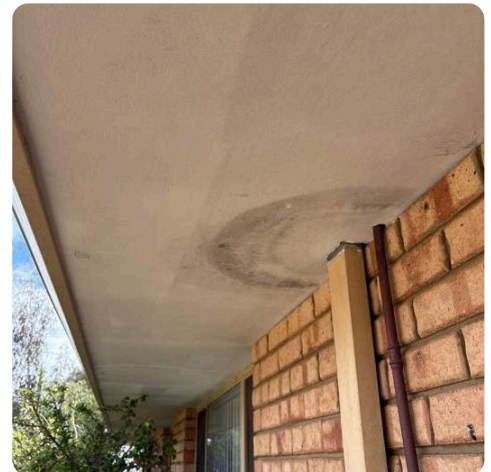
Moisture staining to eaves lining at the downpipe entry, consistent with leakage from the internal downpipe elbow

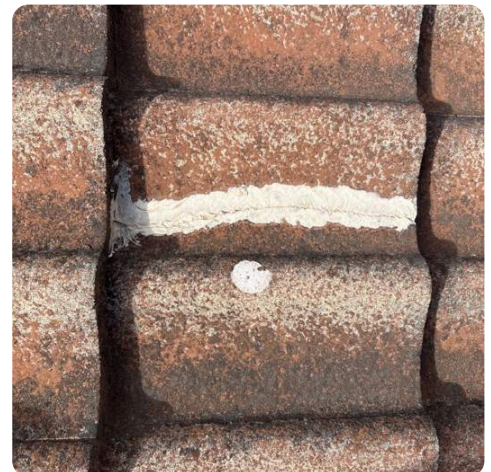
Cracked tile previously repaired with a bead of silicone sealant across the lap

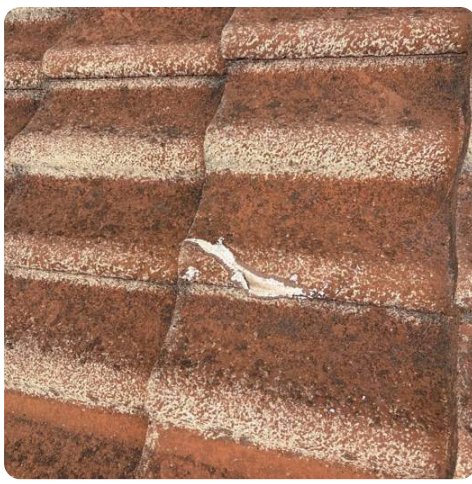
Broken tile section at the lap with exposed substrate

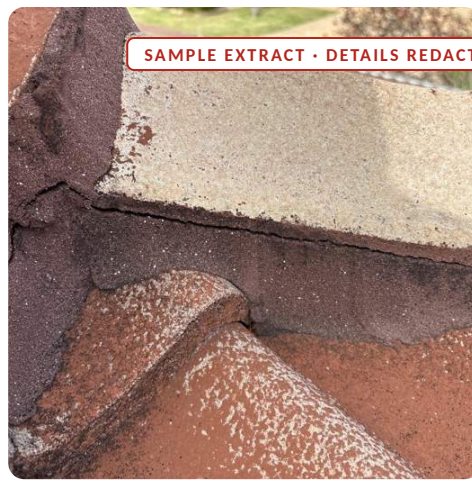
Cracked and eroded cement bedding at the hip and ridge capping junction, capping coating lost

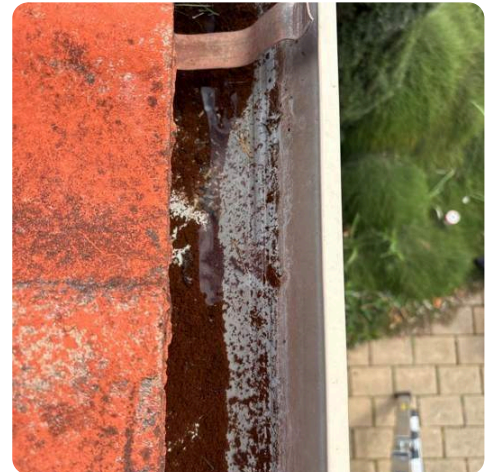
Sections of gutter have previously been replaced and are in good condition. The remaining original sections are free of rust and corrosion and in fair serviceable condition and do not require replacement. At a previous inspection the gutters held a large accumulation of organic matter and leaf litter; this has since been cleared, and only minor debris remains (Unit 1 and Unit 14). The Unit 14 side gutter holds standing water and sediment, indicating inadequate fall toward the outlet; the cause should be confirmed by level before the gutter is refixed (Ref 12).

Gutter holding standing water and sediment, indicating inadequate fall toward the outlet

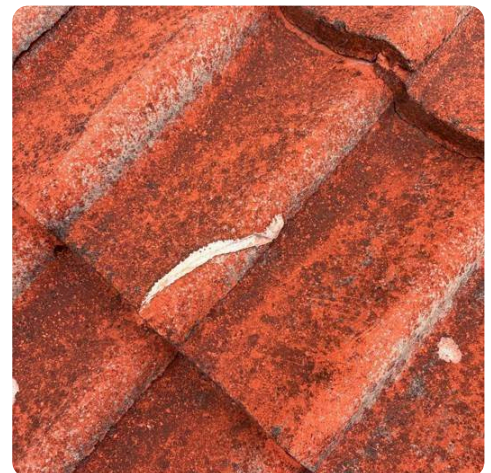
Cracked tile previously repaired with silicone sealant

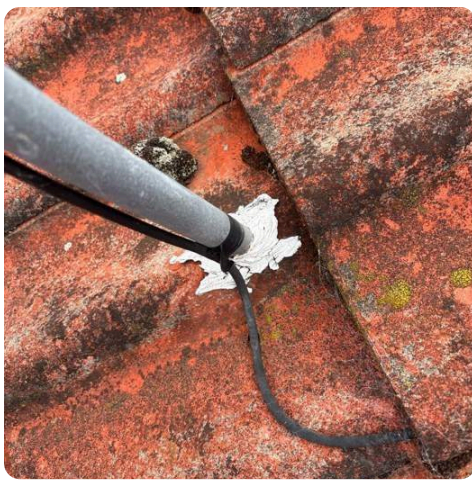
TV antenna mast chased through the tile and sealed with silicone only, no Dektite

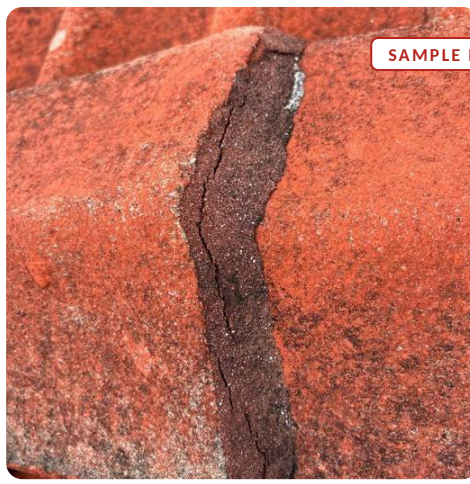
Cracked and eroded cement bedding at the ridge capping joint

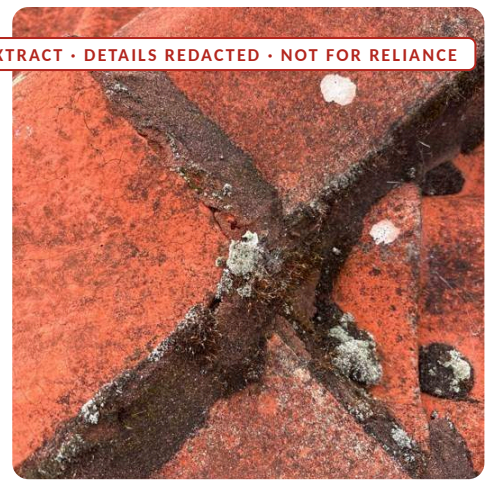
Moss and lichen growth within the ridge capping bedding joint with cracked bedding

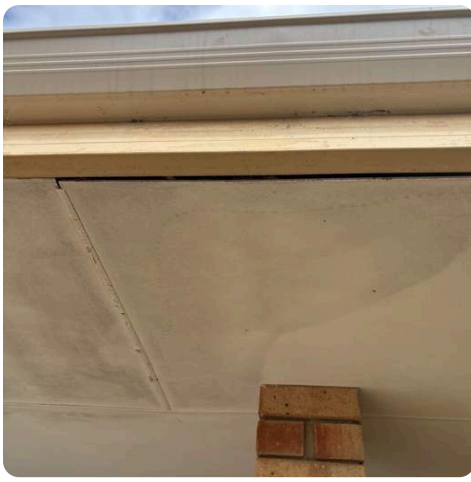
Eaves lining displaced at the fascia line with an open gap and moisture staining

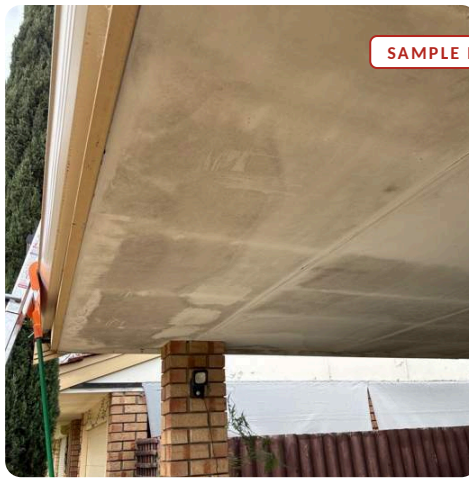
Moisture staining across eaves lining consistent with leakage

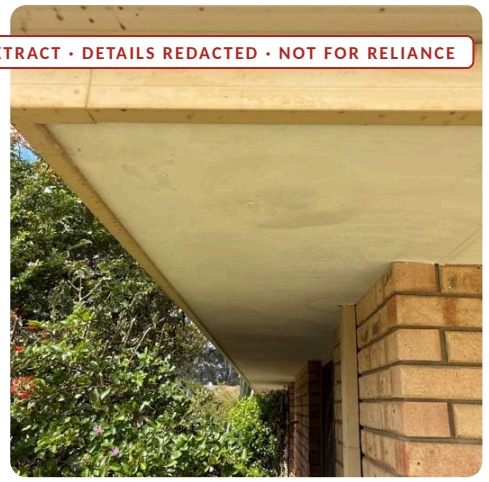
Paint flaking and moisture staining to eaves lining at the corner, consistent with leakage

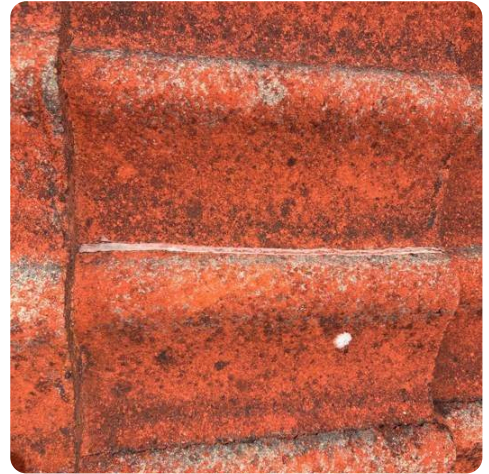
Cracked tile previously sealed with silicone across the lap

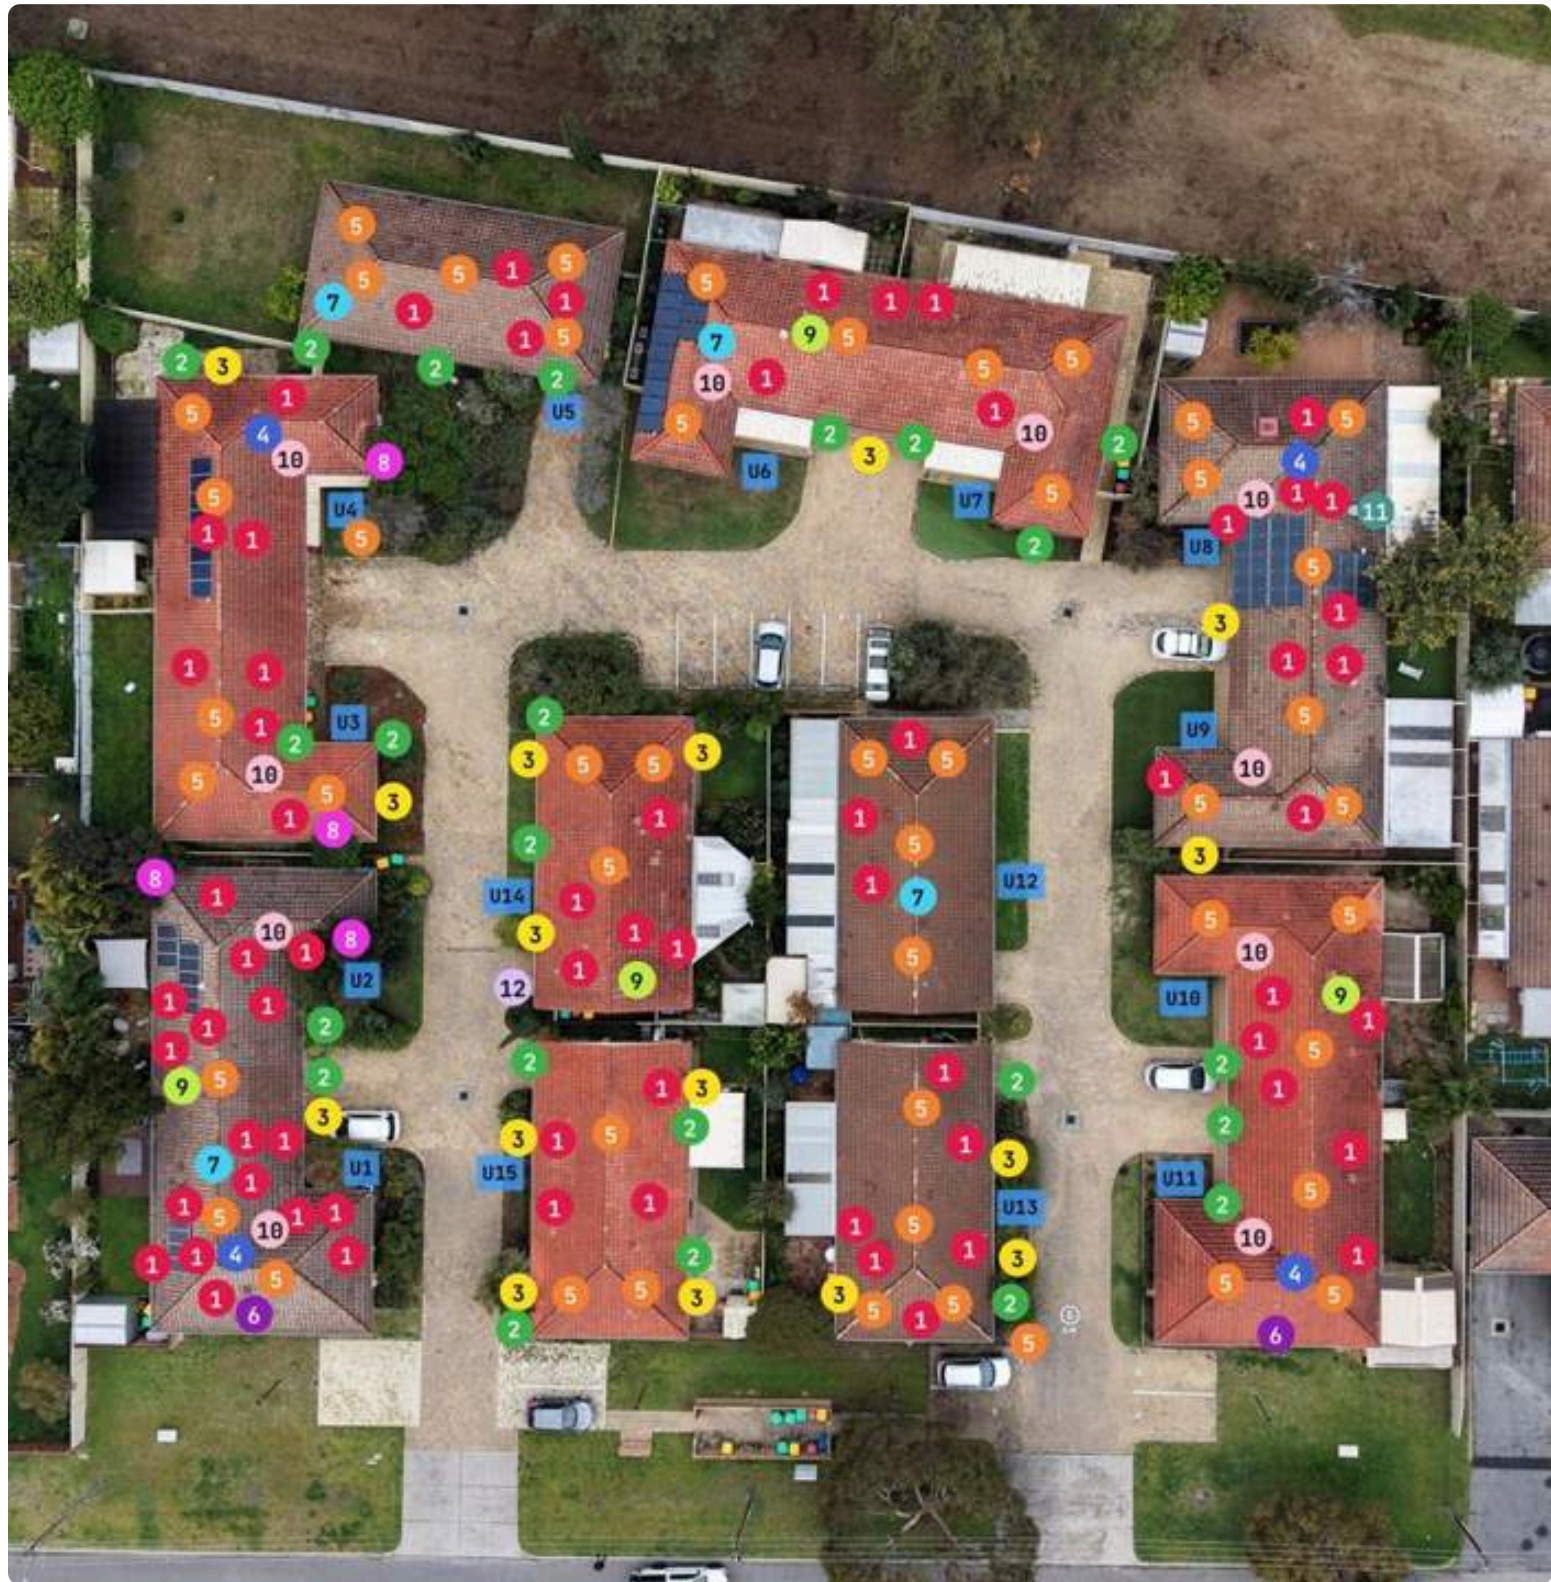
## Annotated Aerial Image

Unit labels U1 to U15 identify each lot. Numbered markers are the defect references in the Aerial Defect Schedule and the unit by unit findings. The complete photographic record for every marker is provided in the separate Photographic Schedule.
