## Strata Scheme Roof Inspection Report

Perth strata scheme  
Address withheld

Elevate Roof & Building  
Solutions Pty Ltd  
Perth, Western Australia

# STRATA SCHEME ROOF INSPECTION REPORT

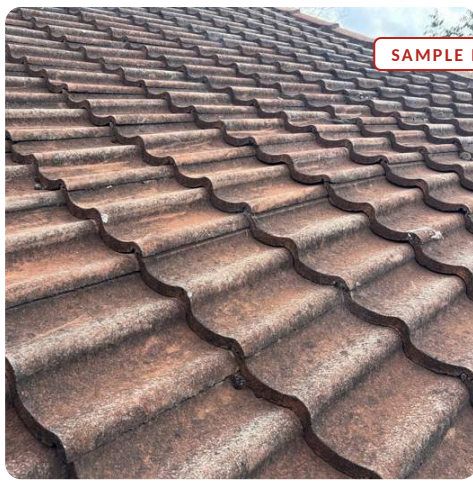
Party wall zone, tiles lifted and misaligned where the wall sits above batten level

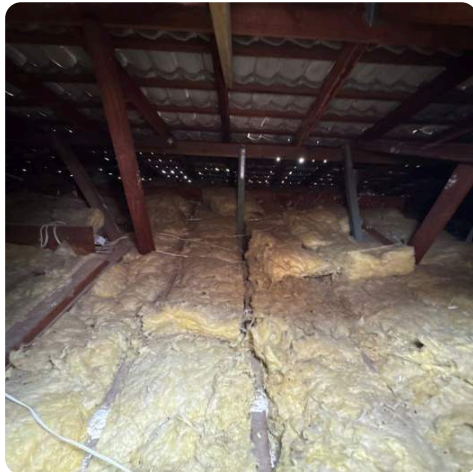
Roof space, timber framing and insulation, daylight visible through tile laps

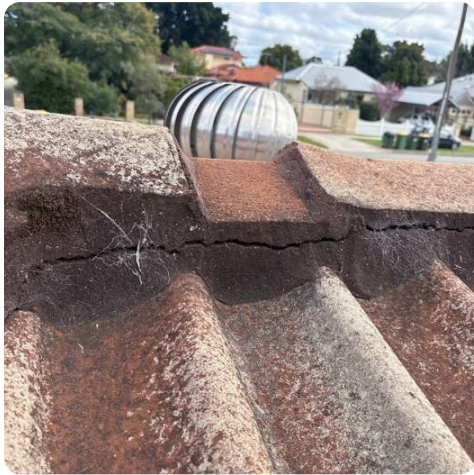
Cement bedding to the ridge and hip capping is cracked, eroded and separating from the capping at most joints inspected across every building, with moss and lichen established along the bedding lines. Where flexible pointing has previously been applied it has separated from the bedding. Sealant has been applied over capping joints and bedding edges at several locations (Units 1, 2 and 14) as a temporary measure. Cracked ridge caps were recorded at Units 1, 5, 6, 7 and 12, and the hip apex caps at Units 13 and 15 have lost their coating to bare substrate. Loose or displaced bedding is addressed within the rebedding and repointing works; only fractured caps require replacement.

Cracked cement bedding and separated flexible pointing to ridge capping

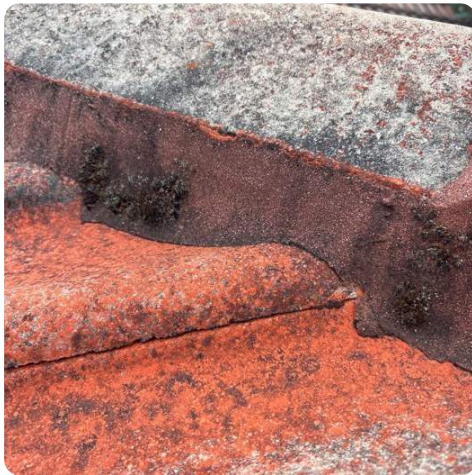
Organic growth to cement bedding beneath ridge capping

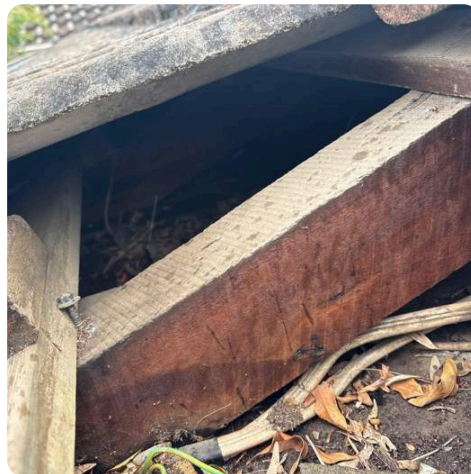
Eaves cavity, moisture staining to rafter consistent with leakage

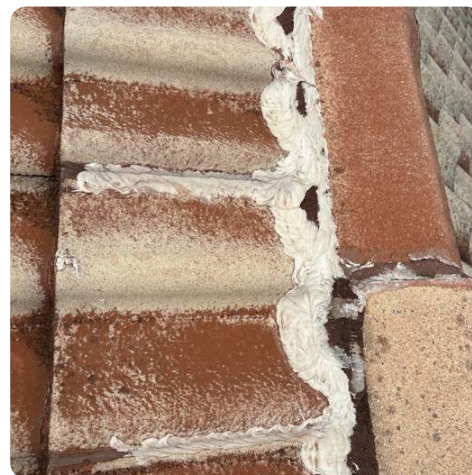
Sealant applied to hip capping bedding and tile laps adjacent to the party wall

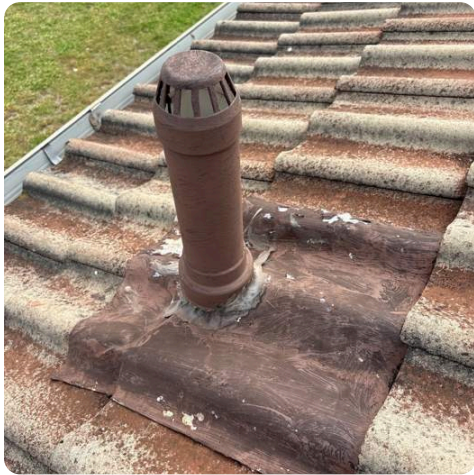
Vent pipe soaker flashing, paint and sealant deteriorating at the collar

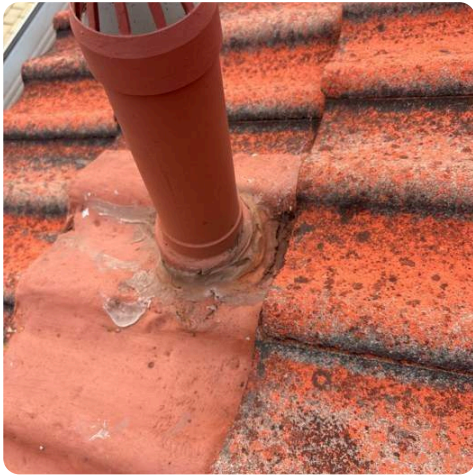
Cracked and deteriorated silicone seal to flue collar and flashing

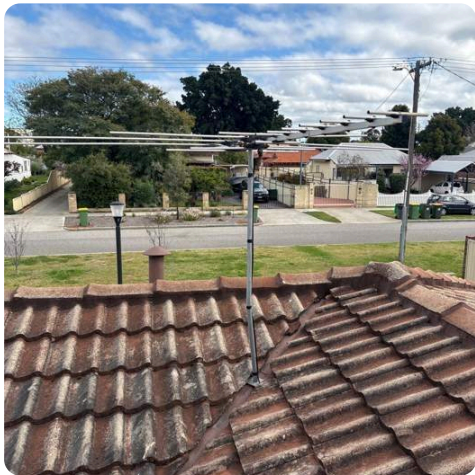
TV antenna masts are mounted directly in the valley flashings at Units 1, 4, 8 and 11, which is inconsistent with accepted roofing practice for a primary drainage path, and chased through tiles or capping with sealant only and no purpose made flashing (Dektite) at Units 2, 6, 10 and 14. The Unit 6 antenna has a broken arm lying loose on the roof surface. Soaker flashings and sealant to vent pipes and flues are deteriorating at Units 1 and 11, with cracked and lifting silicone at the flue collars. The Unit 8 dome skylight is cracked and clouded with sealant repairs at the rim, and its flashing margin is packed with leaf litter and moss beneath the tile cuts. The Unit 8 evaporative cooler tray flashing is sealed with silicone; mineral streaking on the tiles below the unit is consistent with a historic leak from the unit's flexible water hose, which appears to have been replaced recently, and no active leak was observed. Whirlybirds are in fair condition.

TV antenna mast mounted in the valley flashing

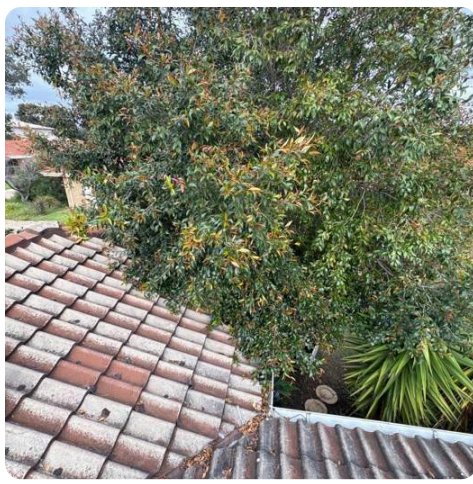
Trees and shrubs overhang the gutters and valleys at Units 2 and 3 (marked), and vegetation sits over the eave edge at Unit 4, the rear gutter at Unit 12 and close to the front gutter at Unit 13 (not marked). Leaf litter from these trees is the source of the organic matter in the valleys and gutters and beneath the solar arrays.

Tree overhanging valley and gutter, debris accumulating

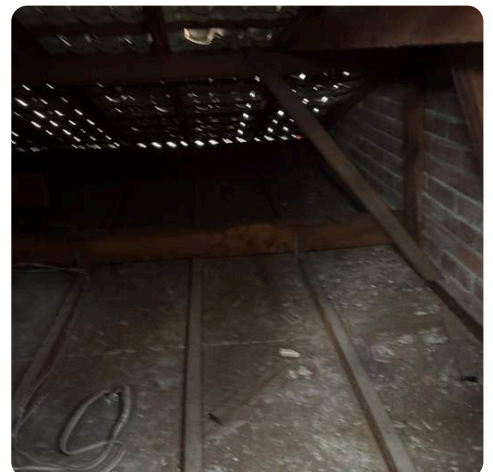
Roof space showing daylight through tile laps, no sarking present

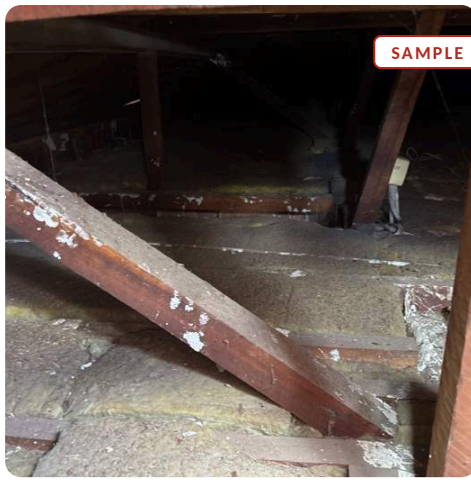
Roof space showing strut and ceiling framing with droppings on timbers

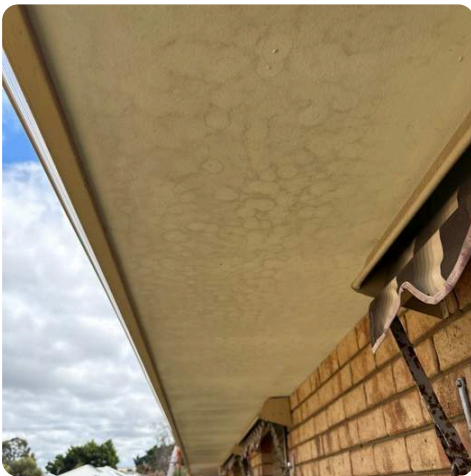
The observed staining patterns are most consistent with a combination of leakage from internal downpipe eaves bends or gutter to downpipe connections, gutter surcharge where effective overflow provisions are absent, and localised roof defects, and not with a single defect: (1) leakage at the internal downpipe eaves bends or at the downpipe connection at the back of the gutter, discharging into the concealed eaves cavity, indicated by staining rings at the downpipe entry points; (2) previous surcharge or overflow over the back edge of the gutter into the eaves lining during heavier rainfall where overflow provisions are absent, indicated by tide marks along the gutter edge and staining at mitres, a condition likely to have been made worse by the organic matter previously held in the gutters, which has since been cleared; and (3) at Unit 1, a broken eaves course tile at the gutter line and sealed broken tiles above the living area providing a path for water to bypass the gutter and track through the eaves cavity into the front living area. The internal bends and connections are concealed and no controlled water testing was undertaken; these mechanisms should be confirmed

Mottled moisture staining to eaves lining along the gutter line consistent with gutter overflow

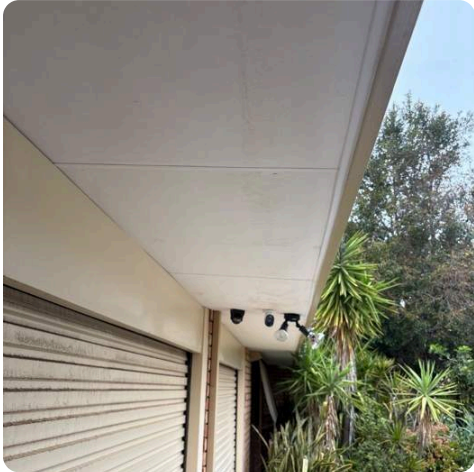
Front eaves lining, moisture staining consistent with leakage across sheet joints

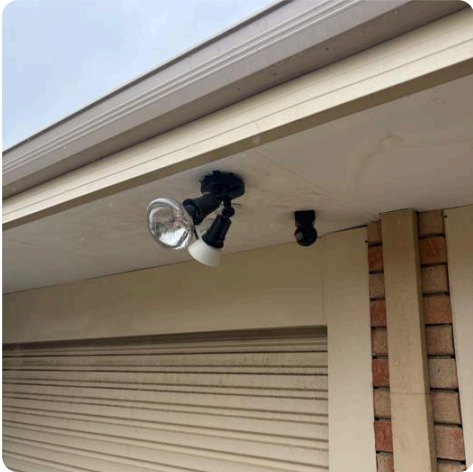
Eaves lining at light fitting, active dripping reported during heavy rainfall

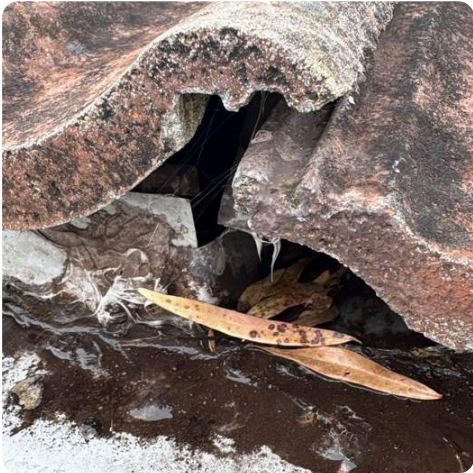
Broken eaves course tile at the gutter line, opening allows water to bypass into the eaves

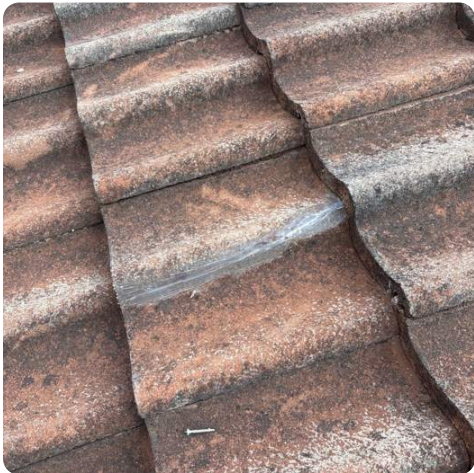
Silicone sealed tile above the living area ingress zone

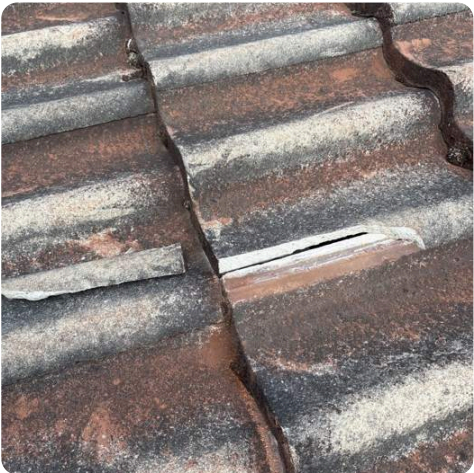
Broken tile with displaced fragment, opening to the tile below

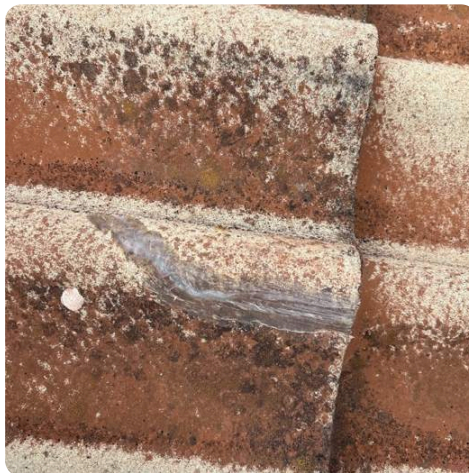
Silicone sealed broken tile

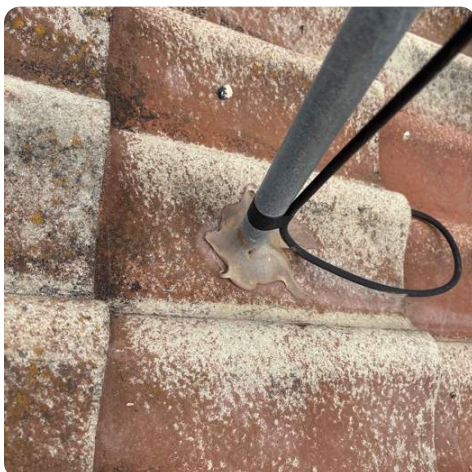
TV antenna mast through tile with sealant only, no Dektite

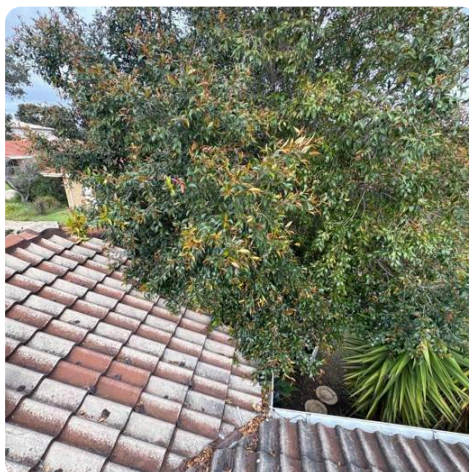
Tree overhanging valley and gutter, debris accumulating

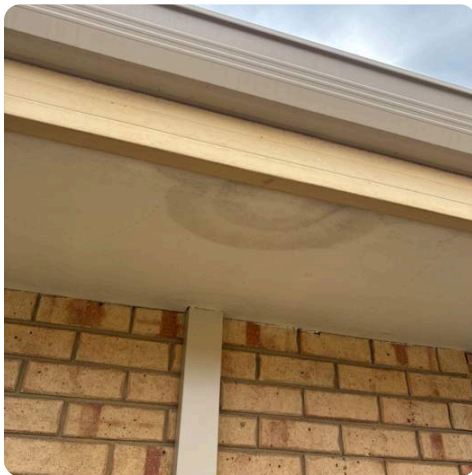
Eaves lining at downpipe, moisture staining consistent with leakage at the gutter connection

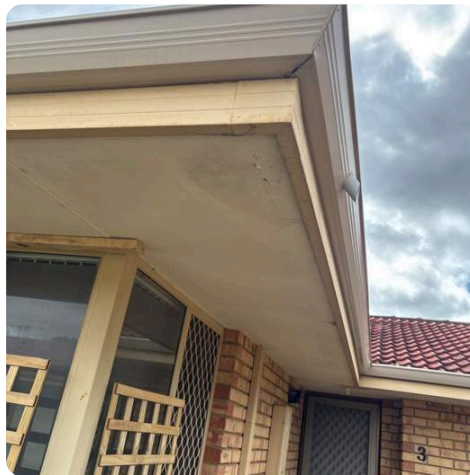
Eaves lining at gutter mitre, moisture staining consistent with leakage

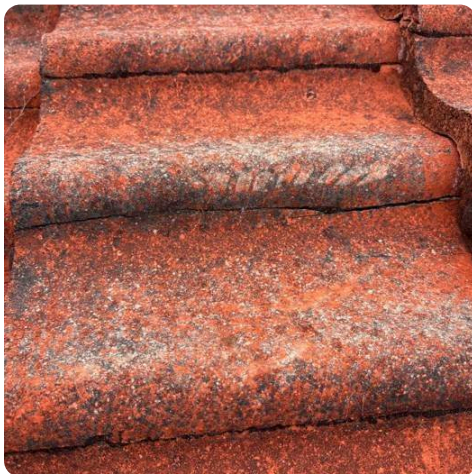
Cracked and spalling tile nose

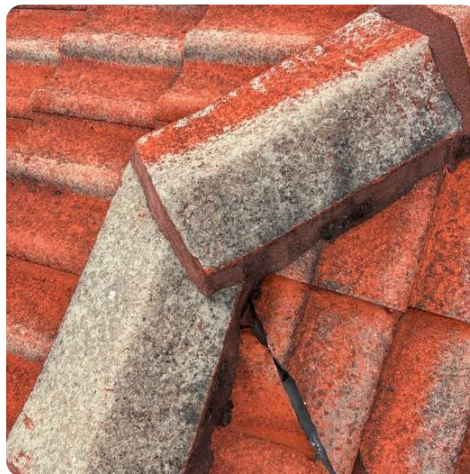
Weathered ridge and hip capping, bedding cracked at apex

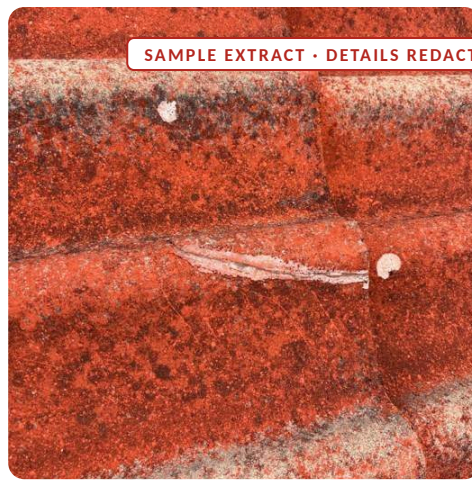
Chipped tile nose exposing substrate

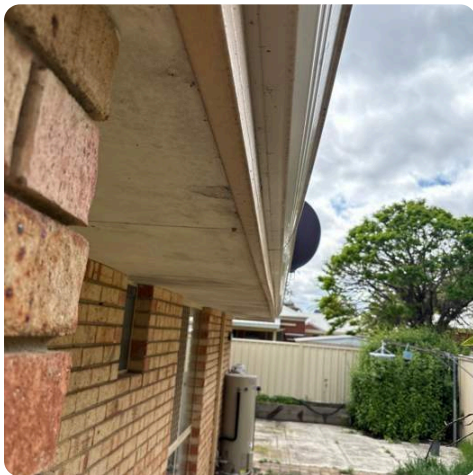
Moisture staining to eaves lining consistent with leakage from gutter overflow

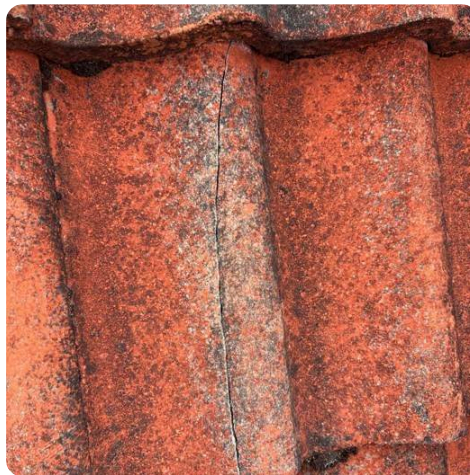
Hairline crack through full length of tile

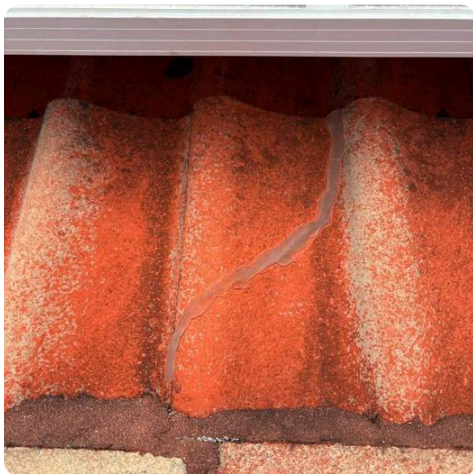
Cracked tile beneath solar panel previously sealed with silicone

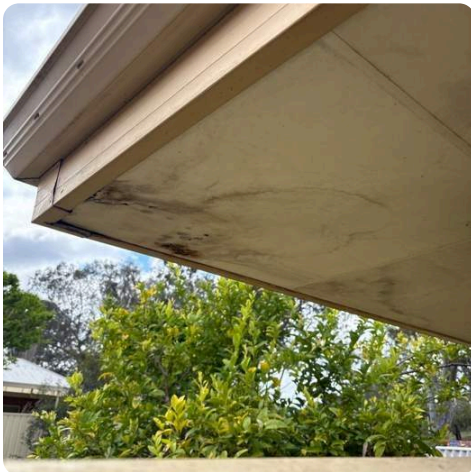
Mould growth and moisture staining to eaves lining at corner consistent with leakage

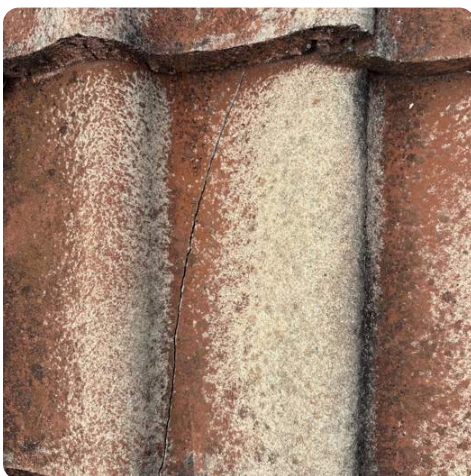
Hairline crack through full length of tile

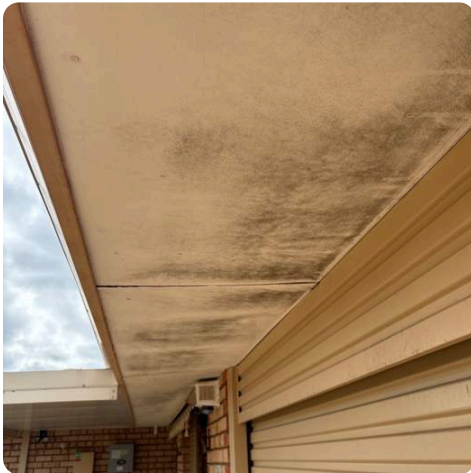
Mould growth and moisture staining to eaves lining above garage consistent with leakage

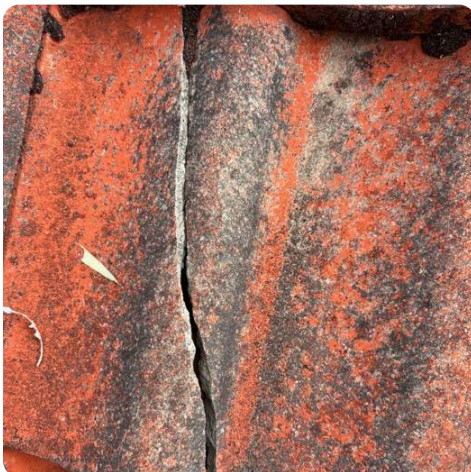
Broken tile with open split

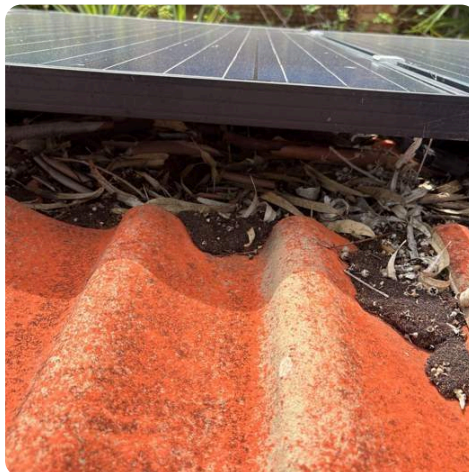
Organic matter build up beneath solar array

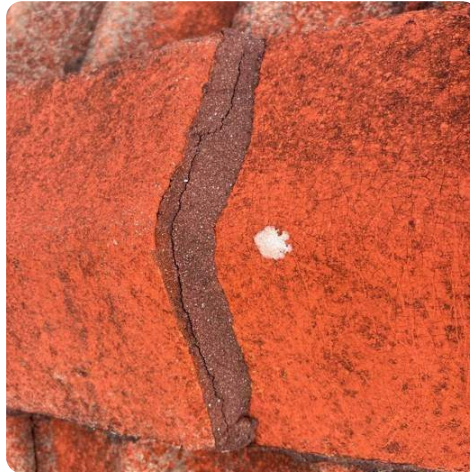
Cracked and separating cement bedding to ridge capping joint

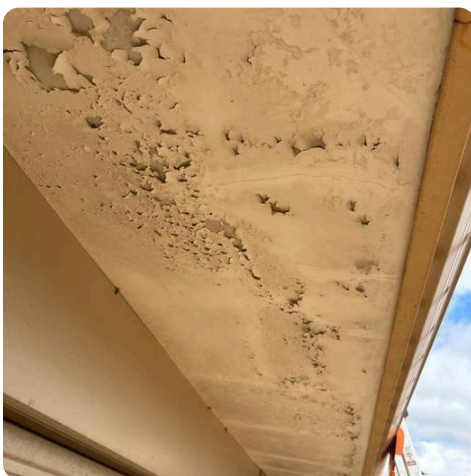
Peeling and blistered paint to eaves lining adjacent to garage, consistent with repeated moisture exposure

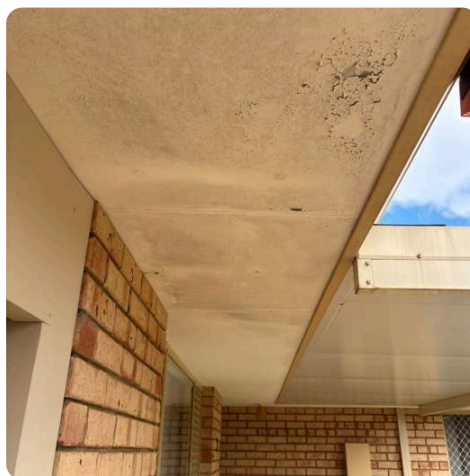
Moisture staining consistent with leakage and blistered paint to eaves lining at front entry

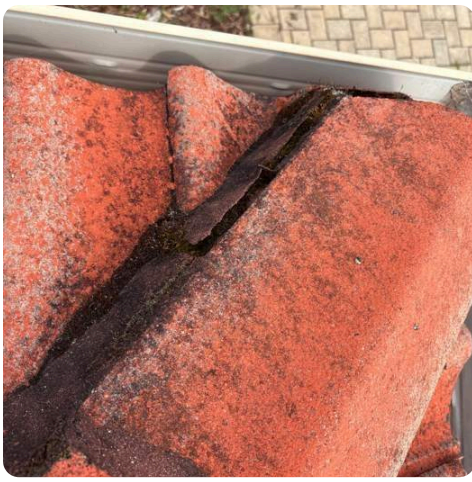
Organic growth held in tile laps at the gutter line

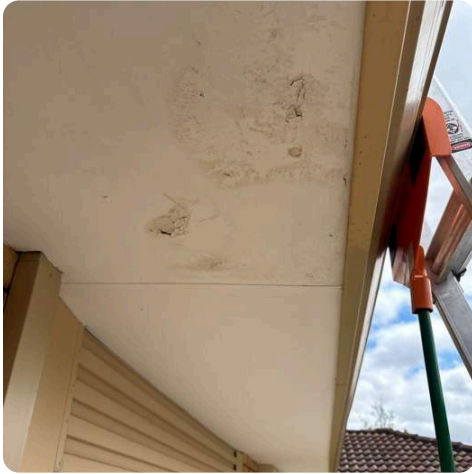
Blistered and peeling paint with moisture staining to eaves lining adjacent to garage

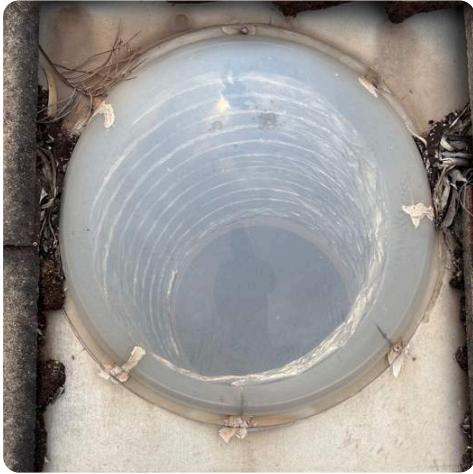
Weathered dome skylight with cracking, sealant repairs at rim and organic matter around flashing

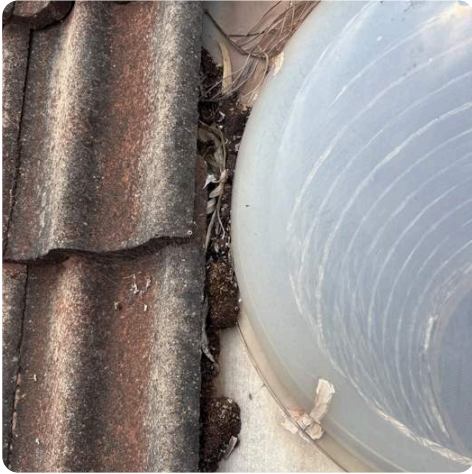
Organic matter packed against skylight flashing beneath tile cuts, restricting drainage

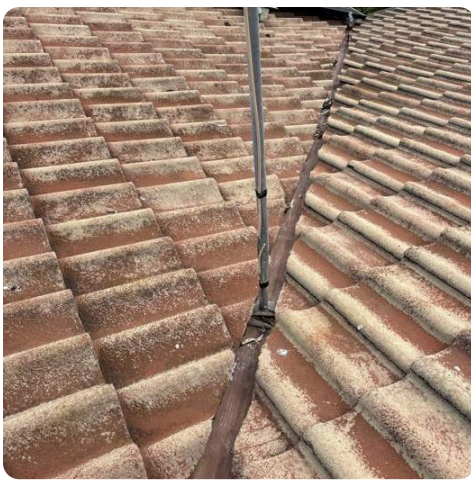
TV antenna mast mounted in valley flashing with cable taped to mast

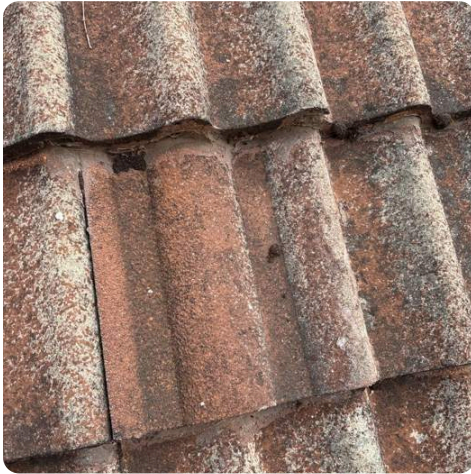
Replacement tile of incorrect profile, gap at head lap packed with mortar

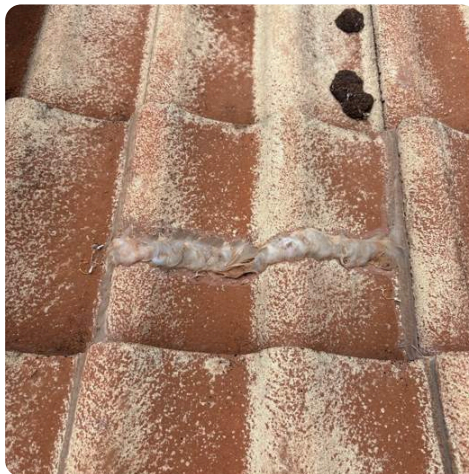
Cracked tile previously silicone sealed across pan, sealant weathered

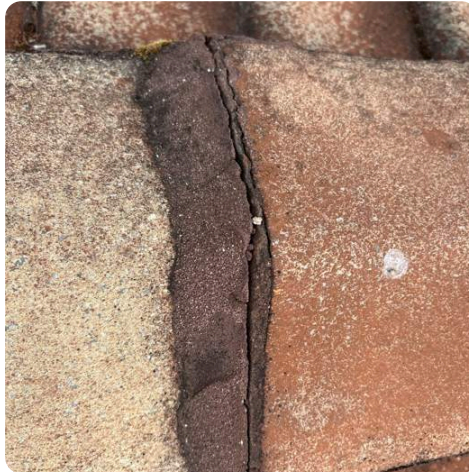
Cracked and separated cement bedding to ridge capping joint

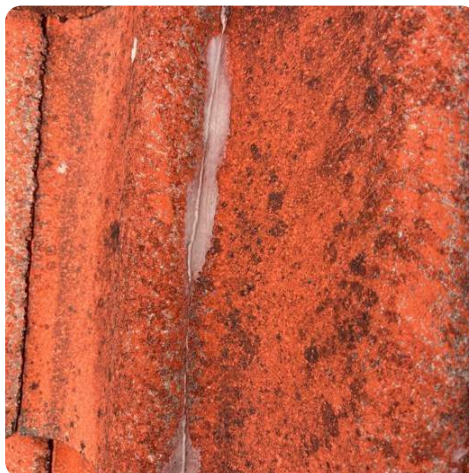
Previously silicone sealed crack to tile, sealant deteriorated and lifting

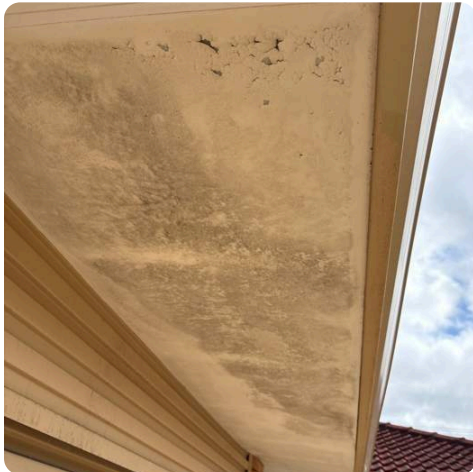
Moisture staining and peeling paint to eaves lining consistent with leakage

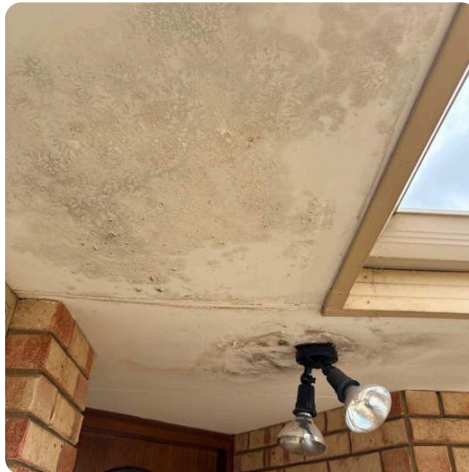
Peeling paint and mould growth to porch lining, moisture staining around light fitting

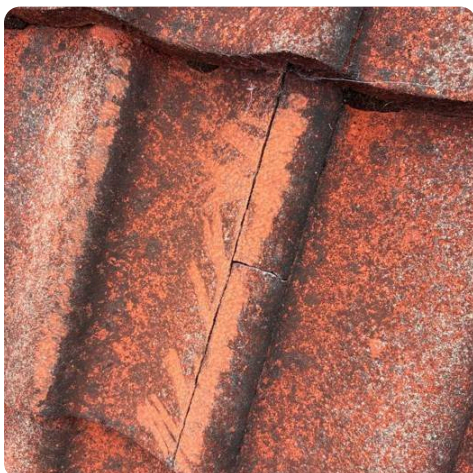
Cracked tile, crack running the full length of the tile

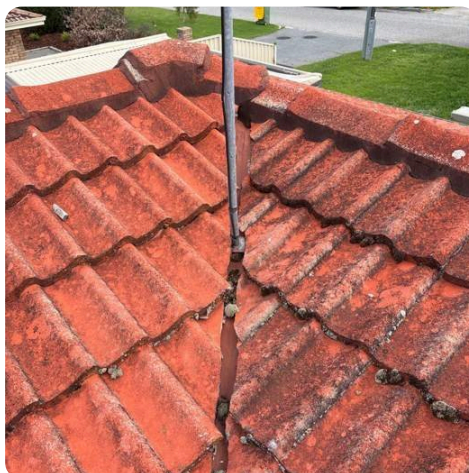
TV antenna mast mounted in the valley flashing, organic matter trapped in the valley

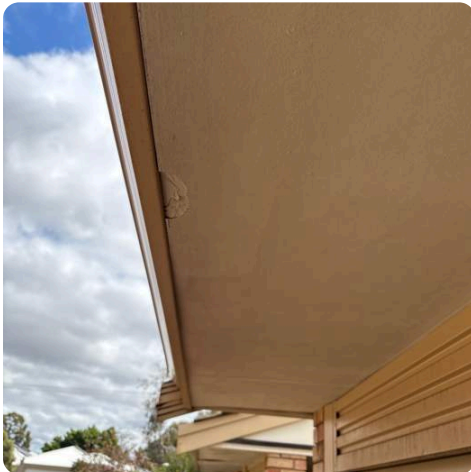
Localised blistering and damage to eaves lining at the fascia edge

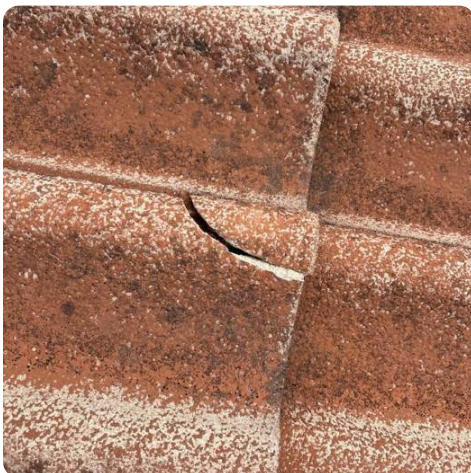
Cracked tile with broken section lifted at the side lap

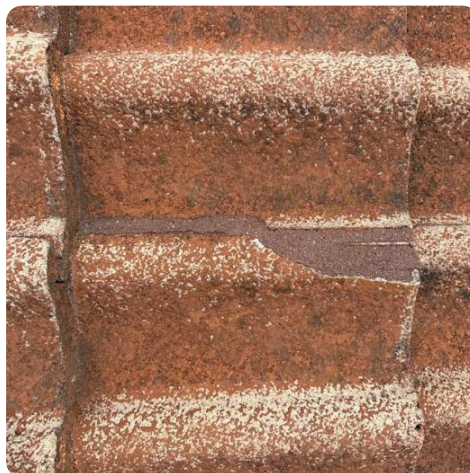
Broken tile, section of lower edge missing exposing the tile below

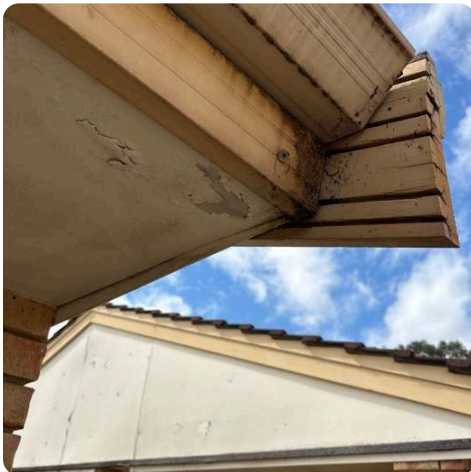
Eaves corner with paint flaking and moisture staining to fascia and eaves lining consistent with leakage from the gutter above

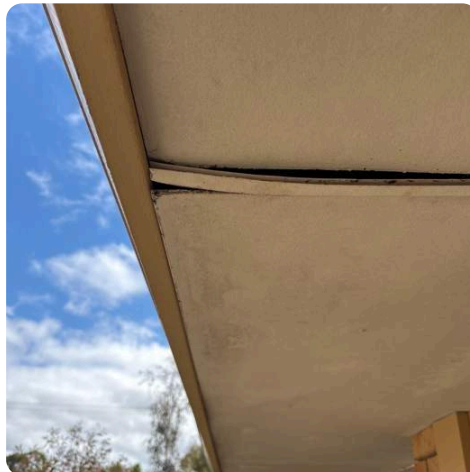
Eaves lining sheet displaced and dropped at the sheet joint adjacent to the fascia

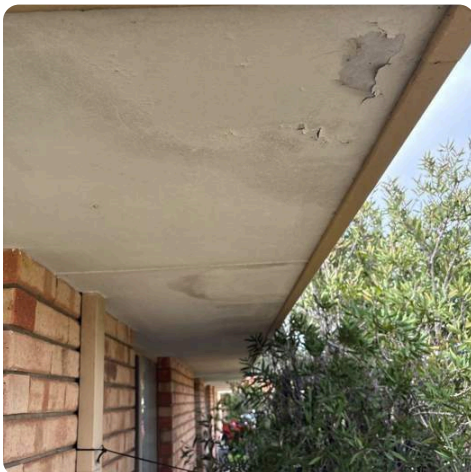
Paint blistering and moisture staining to eaves lining at the hip end corner consistent with leakage

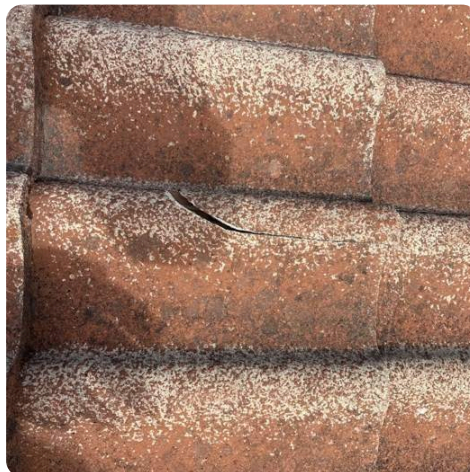
Cracked tile with open fracture across the pan

- Replace all 111x broken, cracked, chipped and previously sealed tiles across the 15x lots with matching profile tiles (counts per unit in the Summary by unit table), including the broken eaves course tile at Unit 1 and the incorrect profile replacement tile at Unit 8.

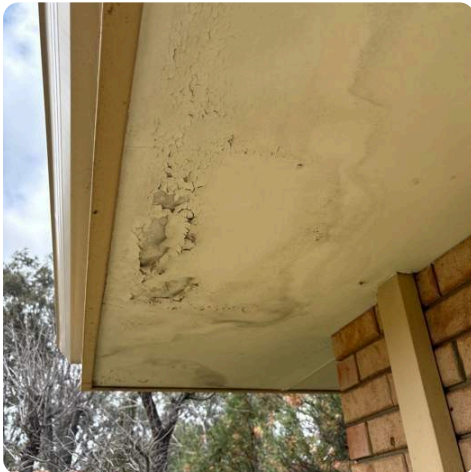
Paint peeling and moisture staining to eaves lining consistent with leakage

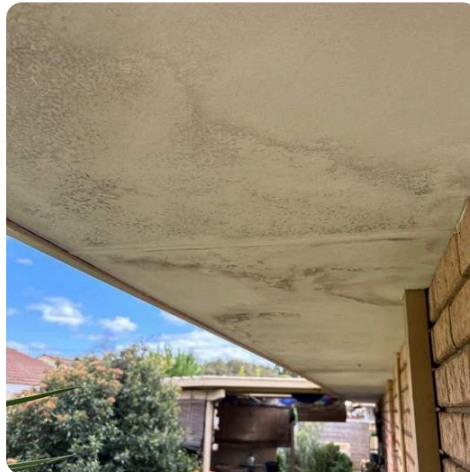
Moisture staining across eaves lining consistent with leakage from the internal downpipe elbow

- Uplift tiles and ridge capping as required at every downpipe position, open the affected eaves areas, test and inspect the internal downpipe eaves bends and the gutter to downpipe connections, and repair or replace each defective bend and connection with new sealed fittings. Reinstall tiles on completion.

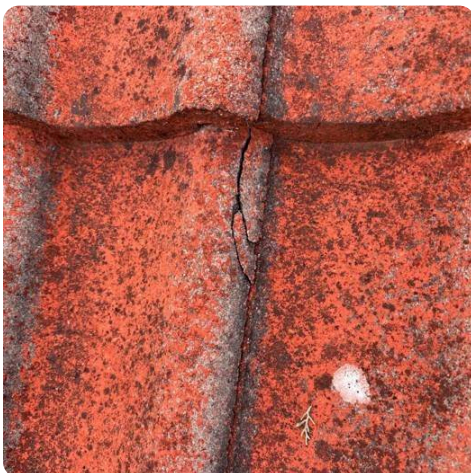
Cracked tile with open fracture running down the pan

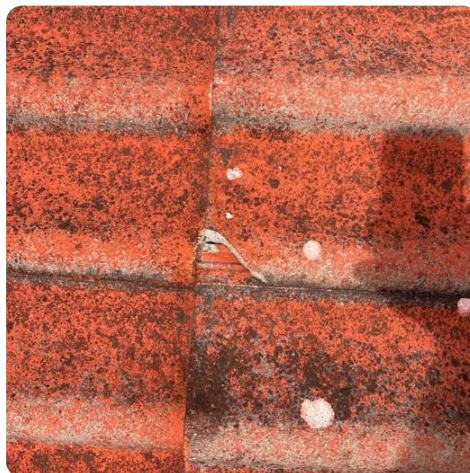
Broken tile corner at the side lap with exposed substrate

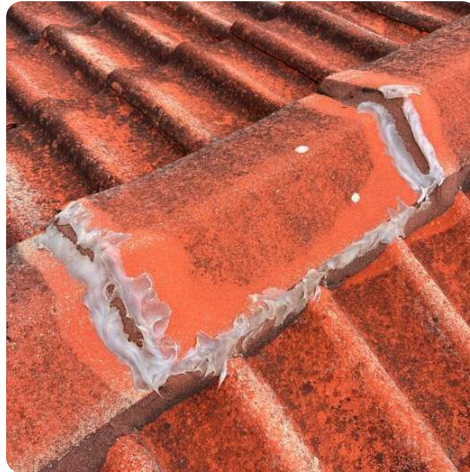
Ridge capping previously sealed with silicone over the bedding joints, sealant weathering

- Full roof restoration to all ten buildings as a single project: pressure clean all roof surfaces; rebed ridge and hip capping where bedding has failed and repoint all ridge and hip capping with flexible pointing; replace the cracked ridge caps at Units 1, 5, 6, 7 and 12 and the spalled apex caps at Units 13 and 15; apply a compatible manufacturer approved primer or undercoat system followed by 2x full coats of a high quality roofing grade membrane coating. The coating protects the tile surface and does not correct installation details; before committing to coating approximately 2,361 m<sup>2</sup>, the restoration contractor is to confirm tile suitability, coating adhesion, compatibility and the proposed manufacturer's system and warranty.

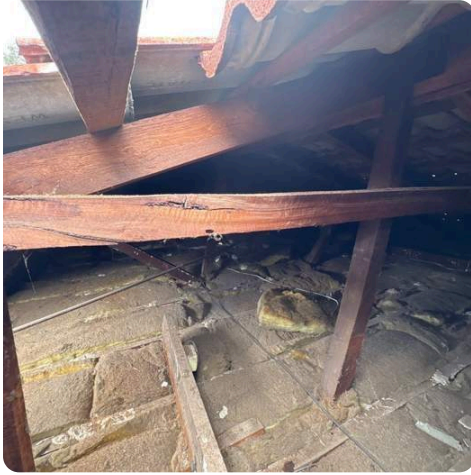
Three items are visible in the photographs that are likely to account for the 2021 comment. The under purlin carries a longitudinal check along the grain at mid depth for several hundred millimetres, opening a few millimetres at its widest; this is consistent with a drying shake in seasoned hardwood of this age and is not a fracture across the grain, and the purlin continues in one piece with the strut beneath bearing tight to its underside. A pine packer has been fitted between the top of the under purlin and the underside of a rafter, which is the usual method of taking up a gap where a rafter has lifted off the purlin or the purlin has settled slightly, and indicates a previous attempt to pack the separation rather than a current open gap. A pine section has been fixed alongside a knotty hardwood rafter, consistent with a previous sistering repair or an original site splice. No open gap between any strut and the purlin, no fractured strut, no member broken across the grain, and no moisture staining to the timbers were observed.

On the basis of the visual inspection the condition is assessed as general age related timber weathering and checking together with evidence of a previous packing repair, with no notable sagging or deflection to the Unit 14 roof beyond that observed to the other roofs in the scheme. No visual condition was identified that indicates an immediate

Hardwood under purlin showing a longitudinal check along the grain

requirement for structural engineering assessment. A licensed carpenter at the time of the roof works: check the under purlin for camber with a string line, confirm the strut bearings and the packer are tight and fixed, and where any deflection is measured, install additional strutting or a supplementary support to the purlin to limit further movement. Engineering assessment should be obtained if measurable deflection, loose bearings, progressive movement or material deterioration is identified. The roof space was viewed from the hatch without string line measurement, load testing or probing; this report is a visual condition assessment and is not a structural certification.

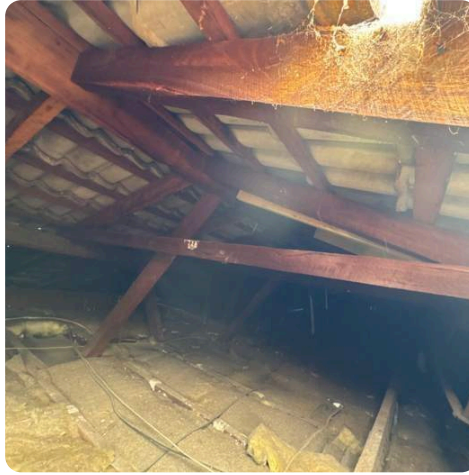
Under purlin and strut with a pine packer fitted between purlin and rafter

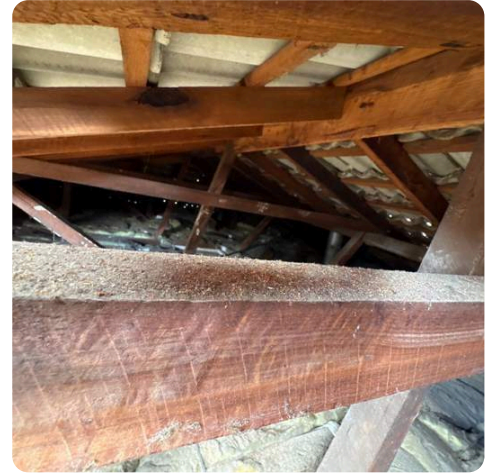
Roof framing showing a rafter with a large knot and a lapped pine section fixed alongside

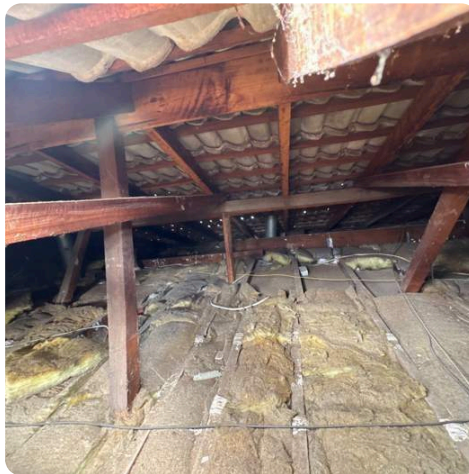
Roof space showing under purlin, struts and flue penetration, tiles unsarked

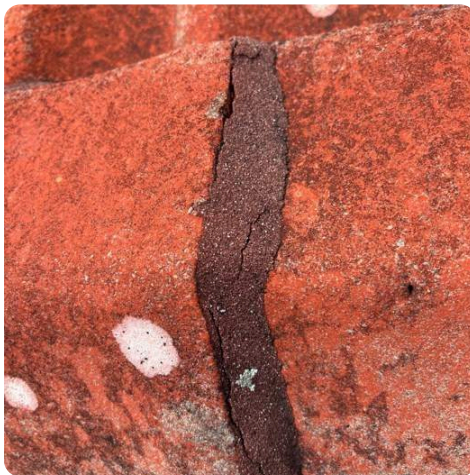
Cracked and eroded cement bedding at the ridge capping joint
