## Strata Scheme Roof Inspection Report

Perth strata scheme  
Address withheld

Elevate Roof & Building  
Solutions Pty Ltd  
Perth, Western Australia

# STRATA SCHEME ROOF INSPECTION REPORT

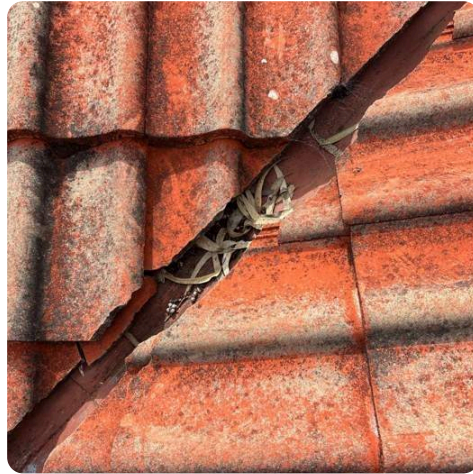
Organic matter trapped in valley beneath tile edges

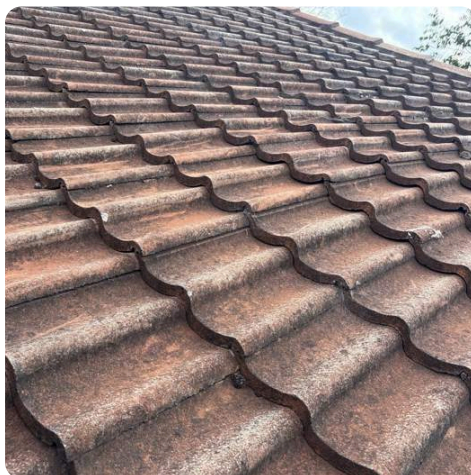
The brick party walls between attached units sit higher than the adjacent roof battens. Tile courses over the party wall line are lifted and misaligned as a result, most visibly at Units 2 and 11. This is common in complexes of this type and age. The displacement opens gaps between the tile laps where wind driven rain can reach beneath the tiles, and with no sarking beneath, this is a potential ingress path onto the ceilings along the party wall lines.

Party wall zone, tiles lifted and misaligned where the wall sits above batten level

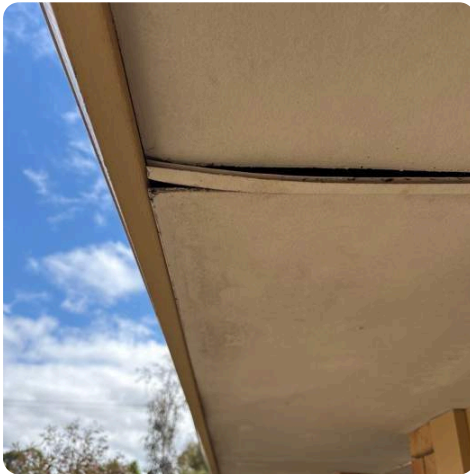
General age related weathering and deterioration of the external roof timbers is noted across the scheme, evidenced by sagging to fascias and by the dropped eaves lining sheets at Units 5, 13 and 15. The condition is consistent with the age of the timbers and their prolonged exposure to moisture from the eaves conditions described above rather than with a structural defect. Fascia and eaves framing condition should be confirmed by the contractor when the eaves linings are opened for repair.

Eaves lining sheet displaced and dropped at the sheet joint adjacent to the fascia

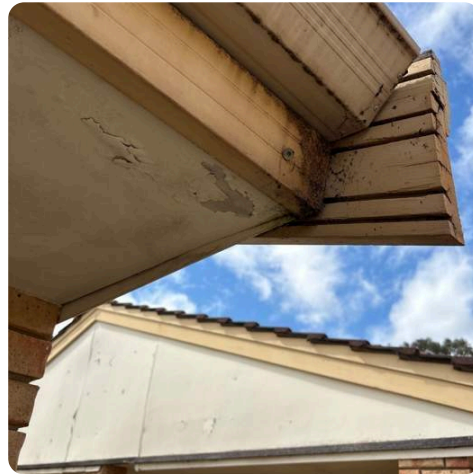
Eaves corner with paint flaking and moisture staining to fascia and eaves lining consistent with leakage from the gutter above

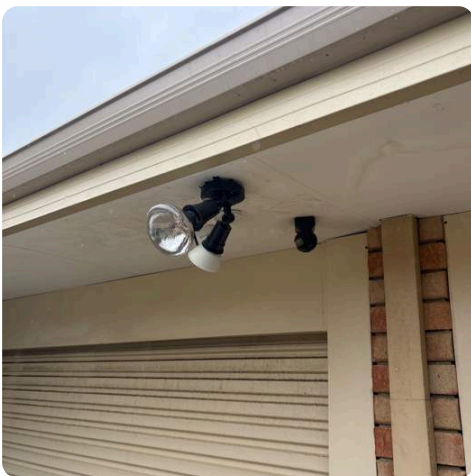
Eaves lining at light fitting, active dripping reported during heavy rainfall

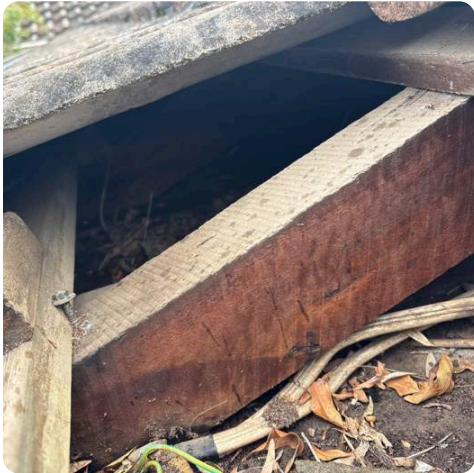
Eaves cavity, moisture staining to rafter consistent with leakage

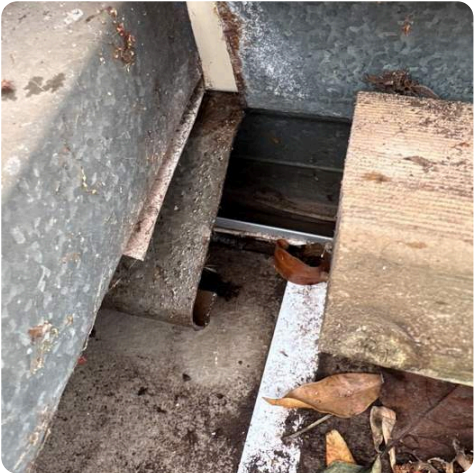
Gutter to downpipe connection, corrosion and debris, suspected leak point into the eaves

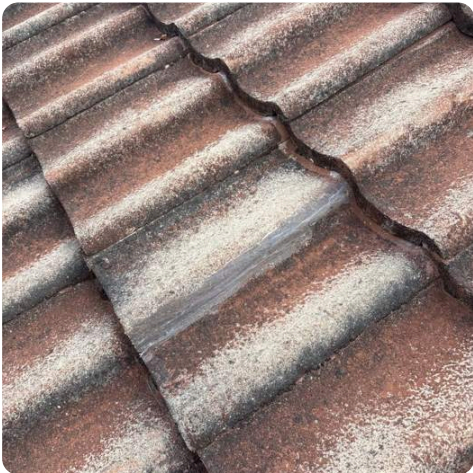
Second silicone sealed tile above the other living area ingress zone

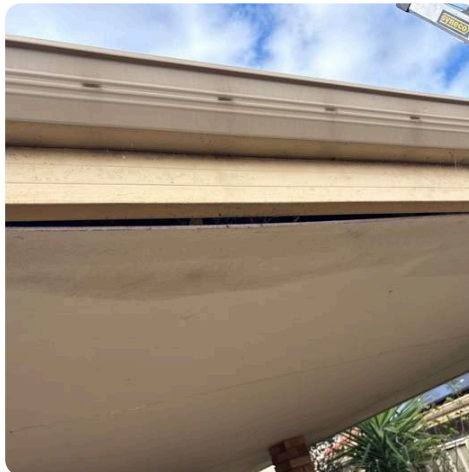
Eaves lining separated from fascia trim leaving open gap

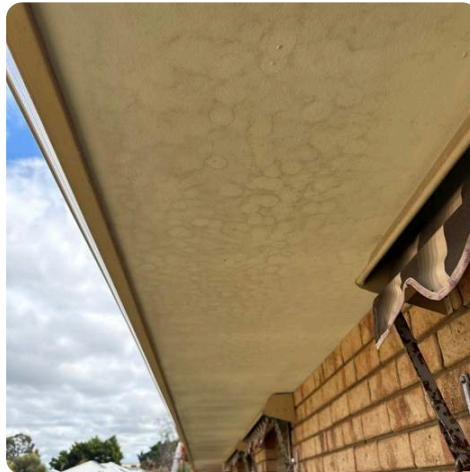
Mottled moisture staining to eaves lining along the gutter line consistent with gutter overflow

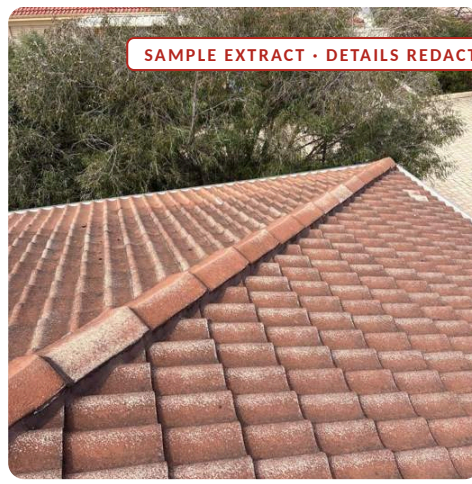
Tree branches overhanging the gutter line at the rear hip
